# CENTRAL VALLEY FLOOD MANAGEMENT PLANNING PROGRAM

## Flood Control System Status Report

December 2011

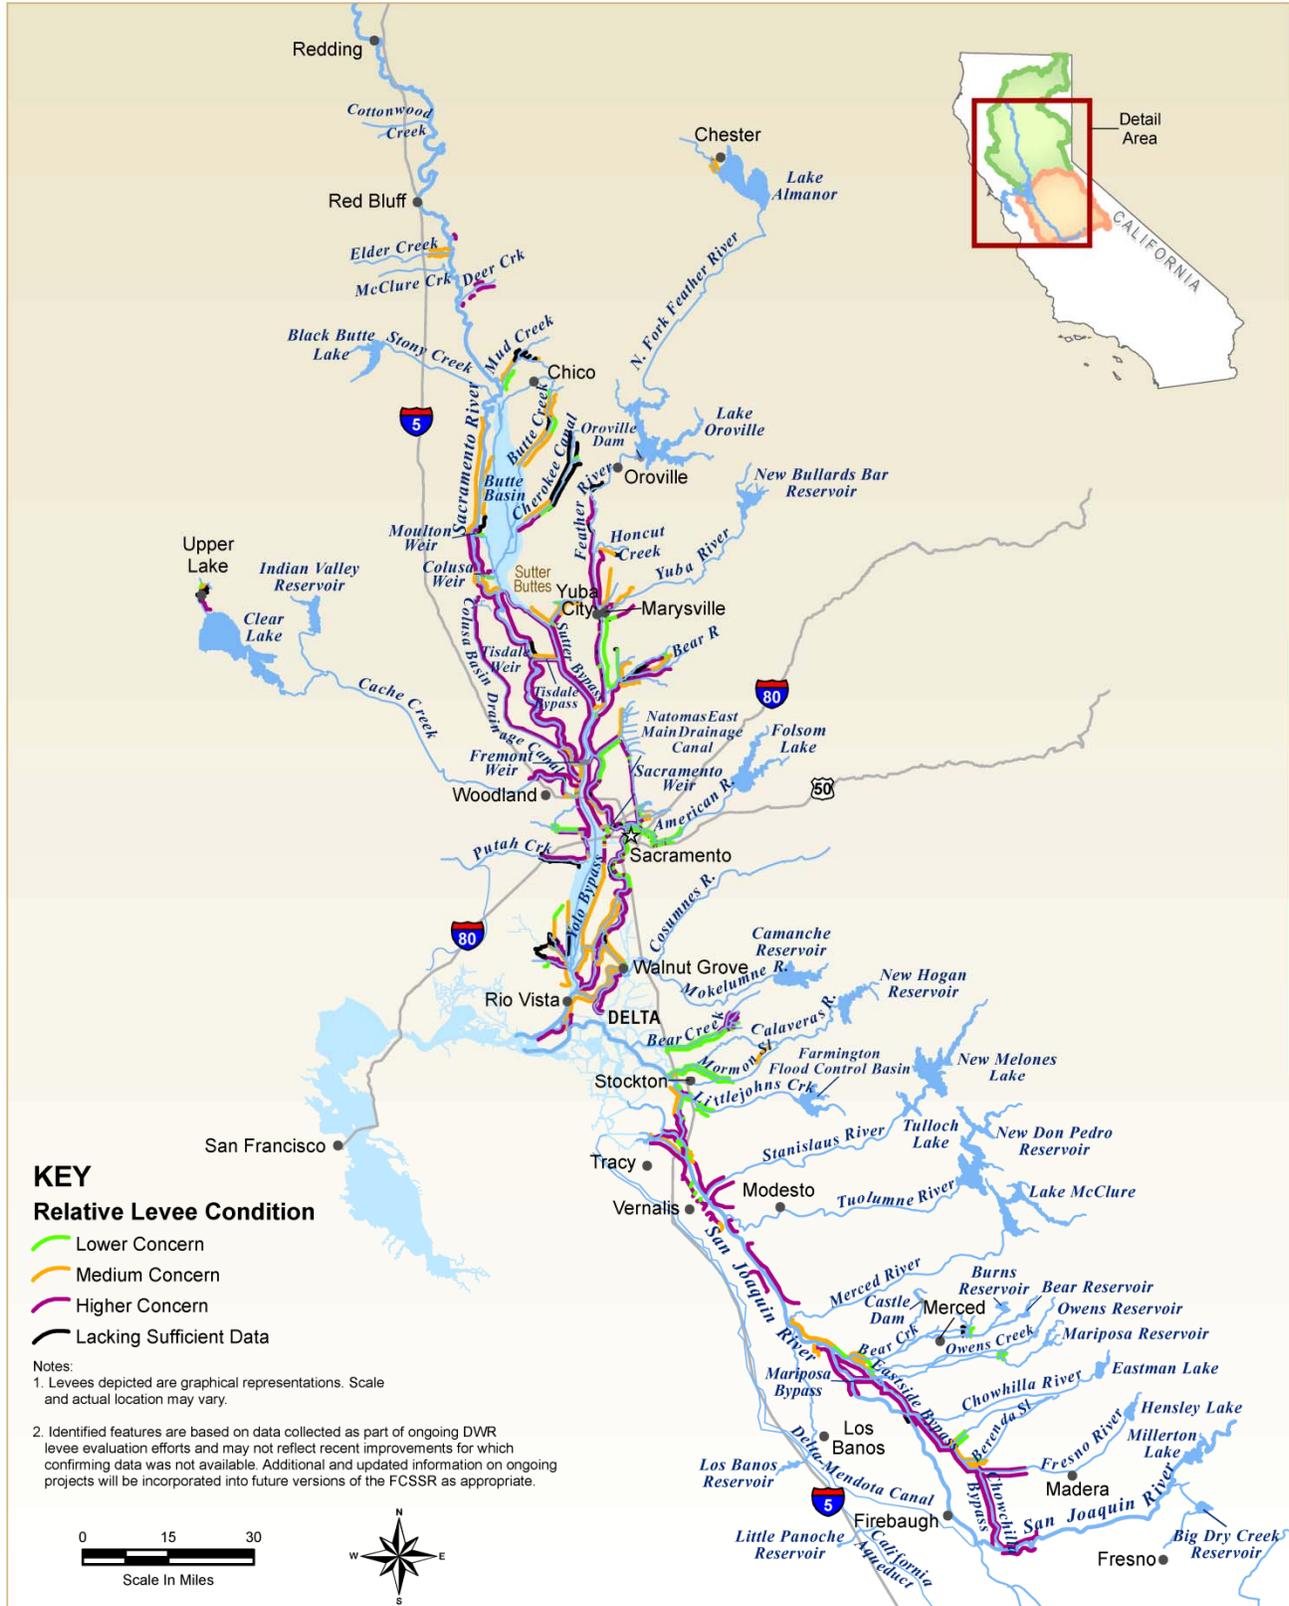
**Figure ES-2. Composite Map of Physical Levee Conditions Based on ULE and NULE Results**

The overall physical condition of SPFC levees, considering most of the levee factors in Table ES-1, is summarized in Figure ES-2. To simplify representation of levee conditions, the figure includes ULE and NULE results that are not directly comparable because different evaluation methodologies were used for each project. The figure is intended to show broadly which levee reaches are of relatively higher, medium, and lower concern, based on physical conditions of the levees. Levees shown as purple (higher concern) on the map generally display more performance problems than those shown in green (lower concern). Results do not reflect economic or life safety consequences of flooding, which are key factors in planning system repairs and improvements. As mentioned, potential economic and life safety consequences associated with flooding are being evaluated as part of the CVFPP.

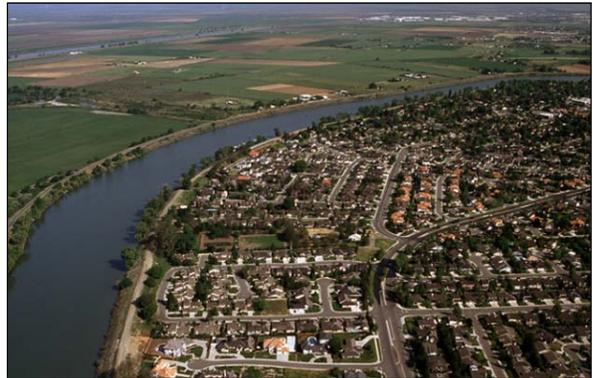
Opposite sides of a river reach can have different flood risks because of different consequences of failure

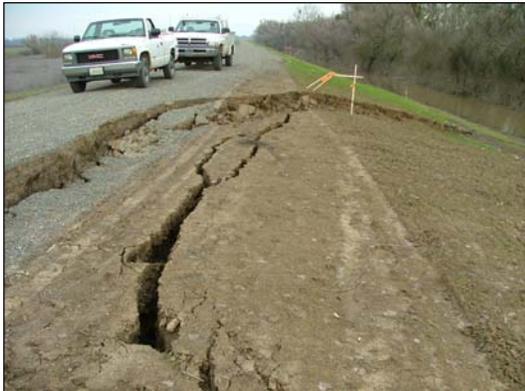
Levee stability concerns

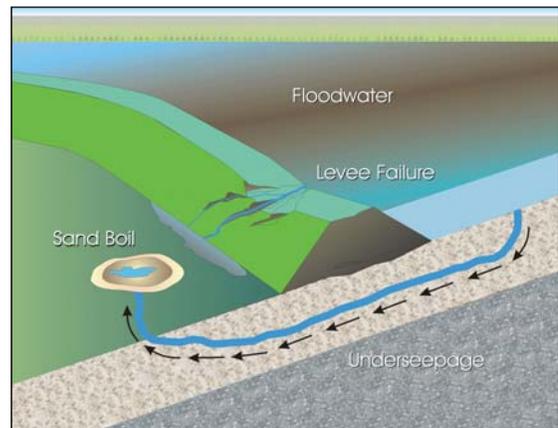
Levee under-seepage

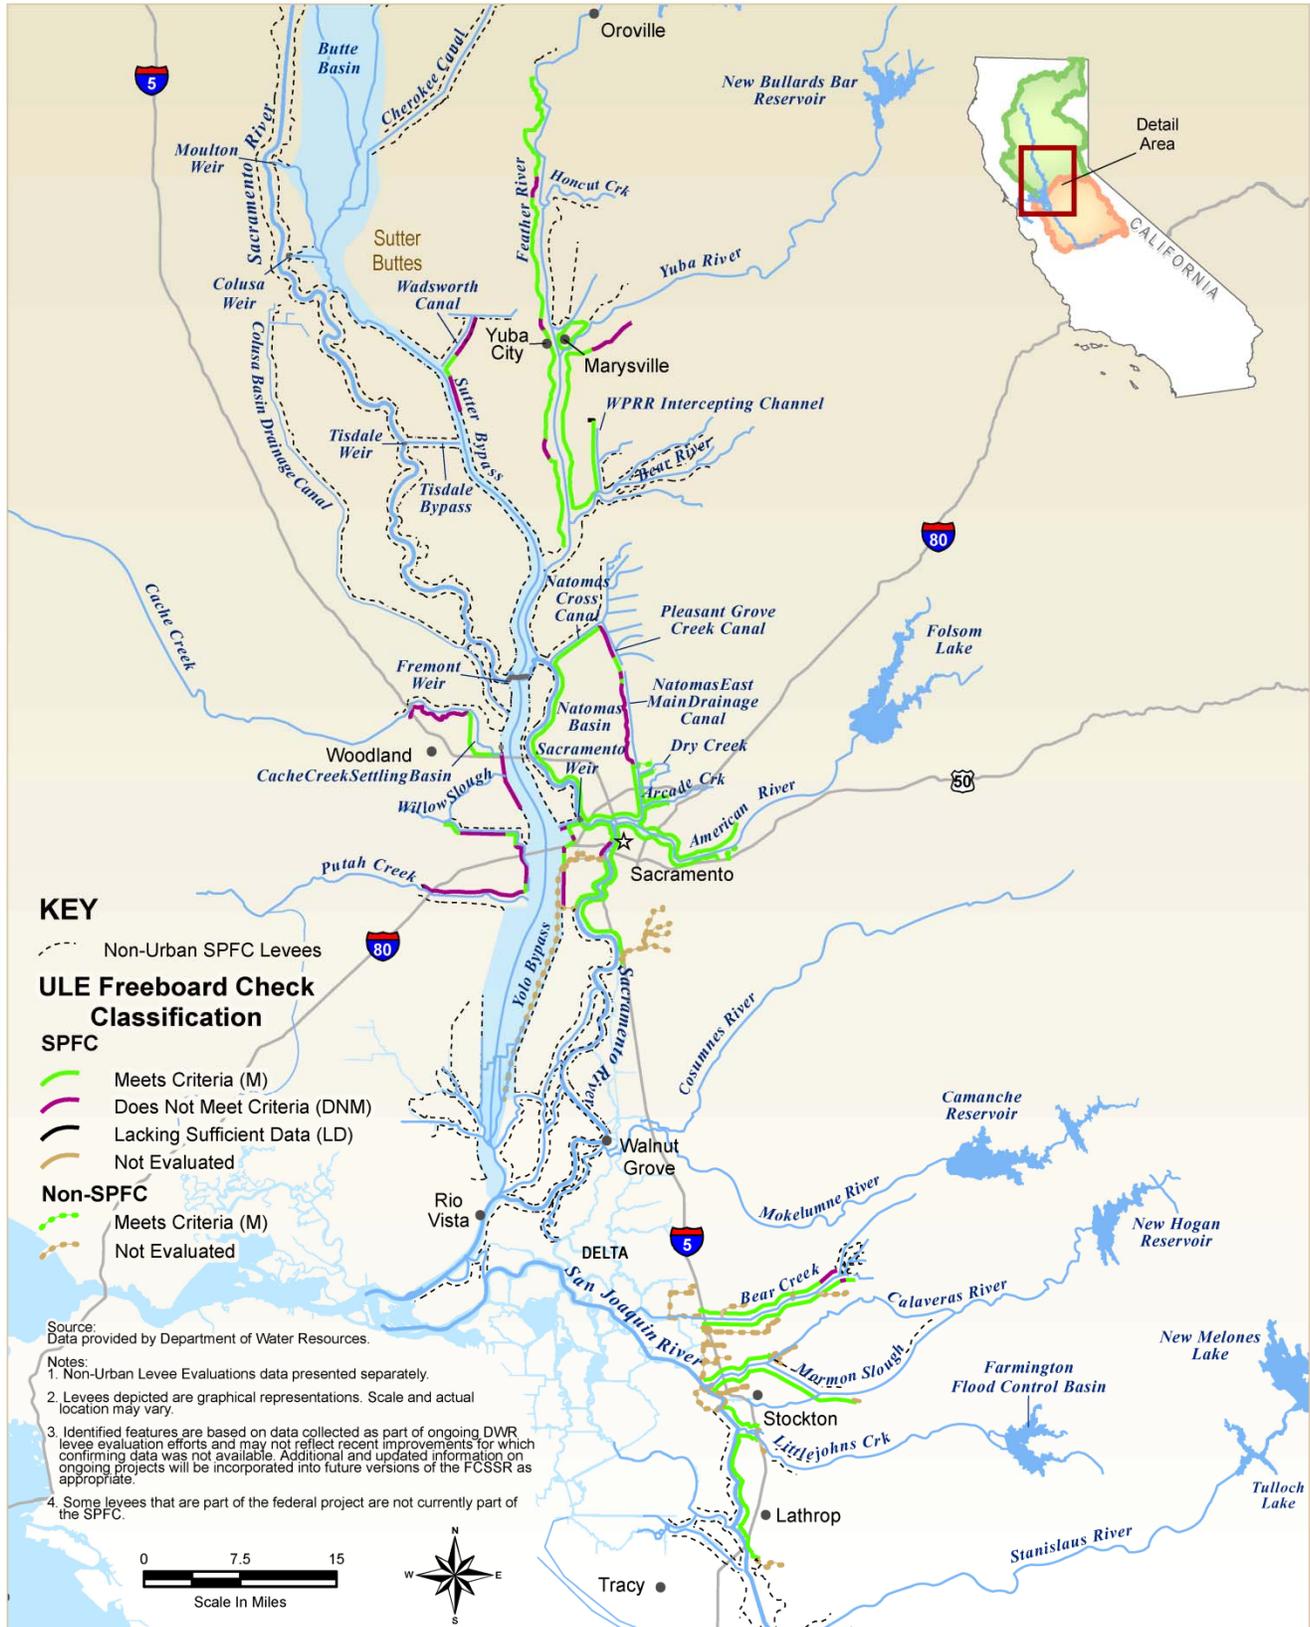
Figure A-6. ULE Freeboard Check Results

ULE freeboard check results are shown on Figure A-6. Levees that do not meet freeboard criteria include portions of the Pleasant Grove Creek Canal and Natomas East Main Drainage Canal, the south bank of the Yuba River east of Marysville, the Davis/Woodland area and along Upper Bear Creek.

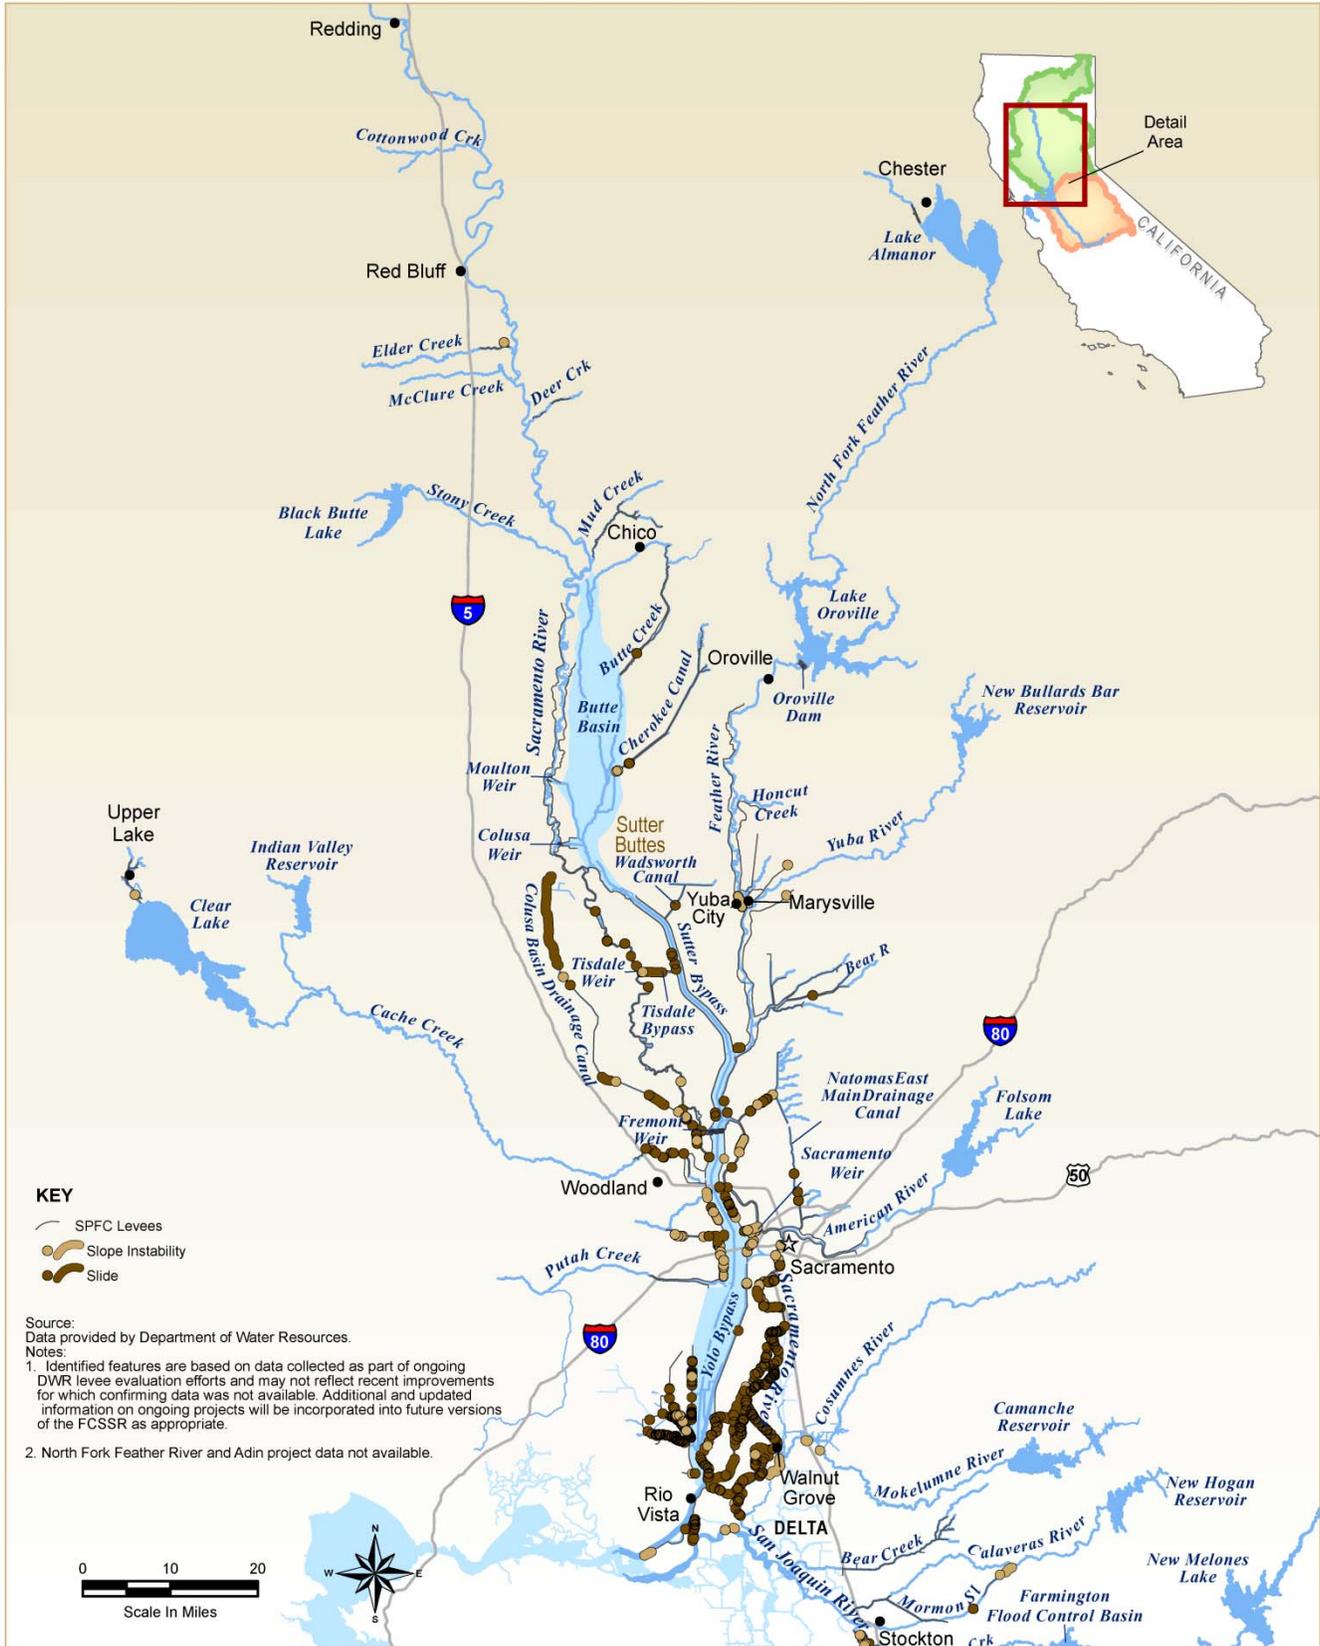
Figure A-19. Historical Slope Instability Occurrences in Sacramento River Watershed

The ULE and NULE projects collected and cataloged information on historical occurrences of levee slope instability. Figures A-19 and A-20 show historical slope instability occurrences collected from the ULE and NULE projects for the Sacramento and San Joaquin river watersheds, respectively. In the Sacramento River watershed, historical levee slope instability occurrences were located most frequently in the lower Sacramento River watershed south of the Fremont Weir. Slope instability was most prevalent on the Sacramento River south of Sacramento and in the north Delta. In the San Joaquin River watershed, historical levee slope instability occurrences were prevalent through the watershed.

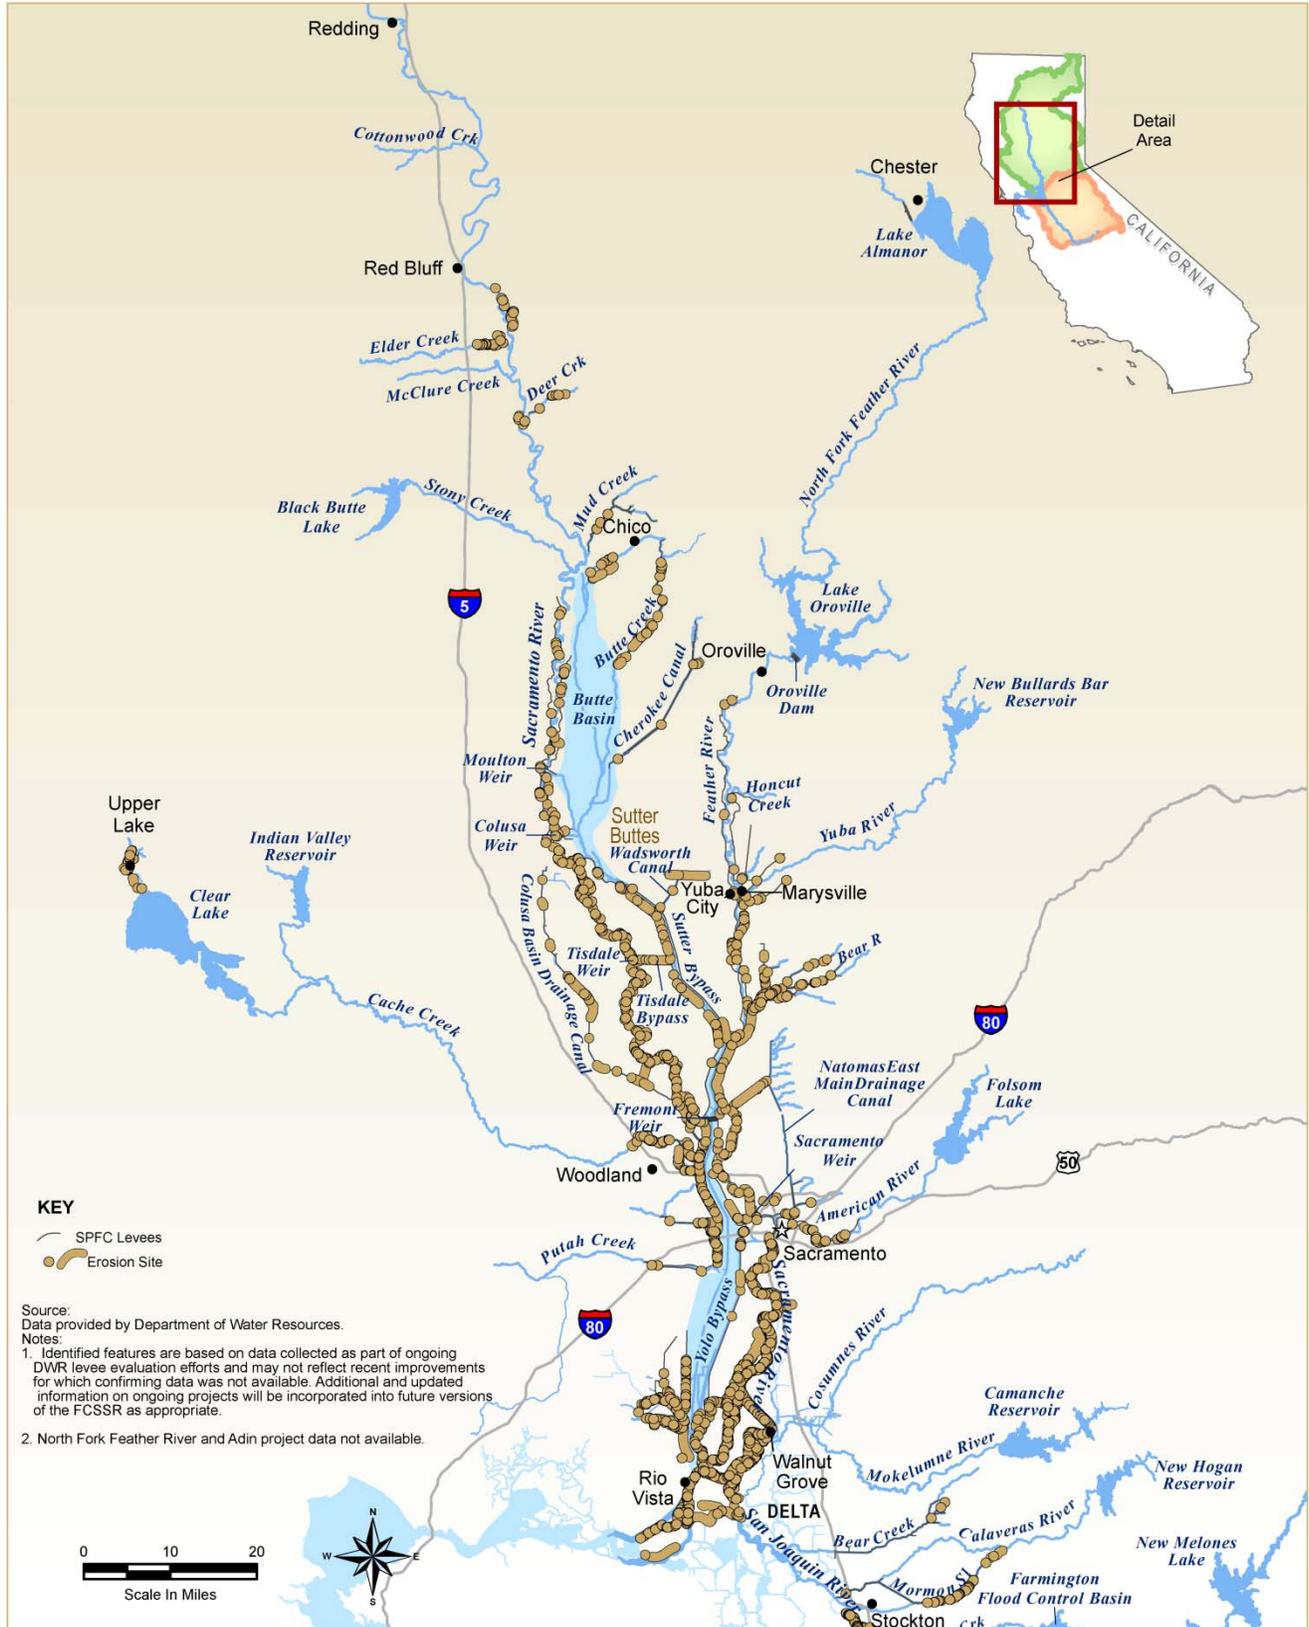
Figure A-23. Historical Erosion Occurrences in Sacramento River Watershed

The ULE and NULE projects collected and cataloged information on historical occurrences of levee erosion and completed or planned repairs or improvements. Figures A-23 and A-24 show historical erosion occurrences for the Sacramento and San Joaquin river watersheds, respectively. Historical erosion occurrences were located throughout almost all SPFC levees of the Sacramento and San Joaquin river watersheds.

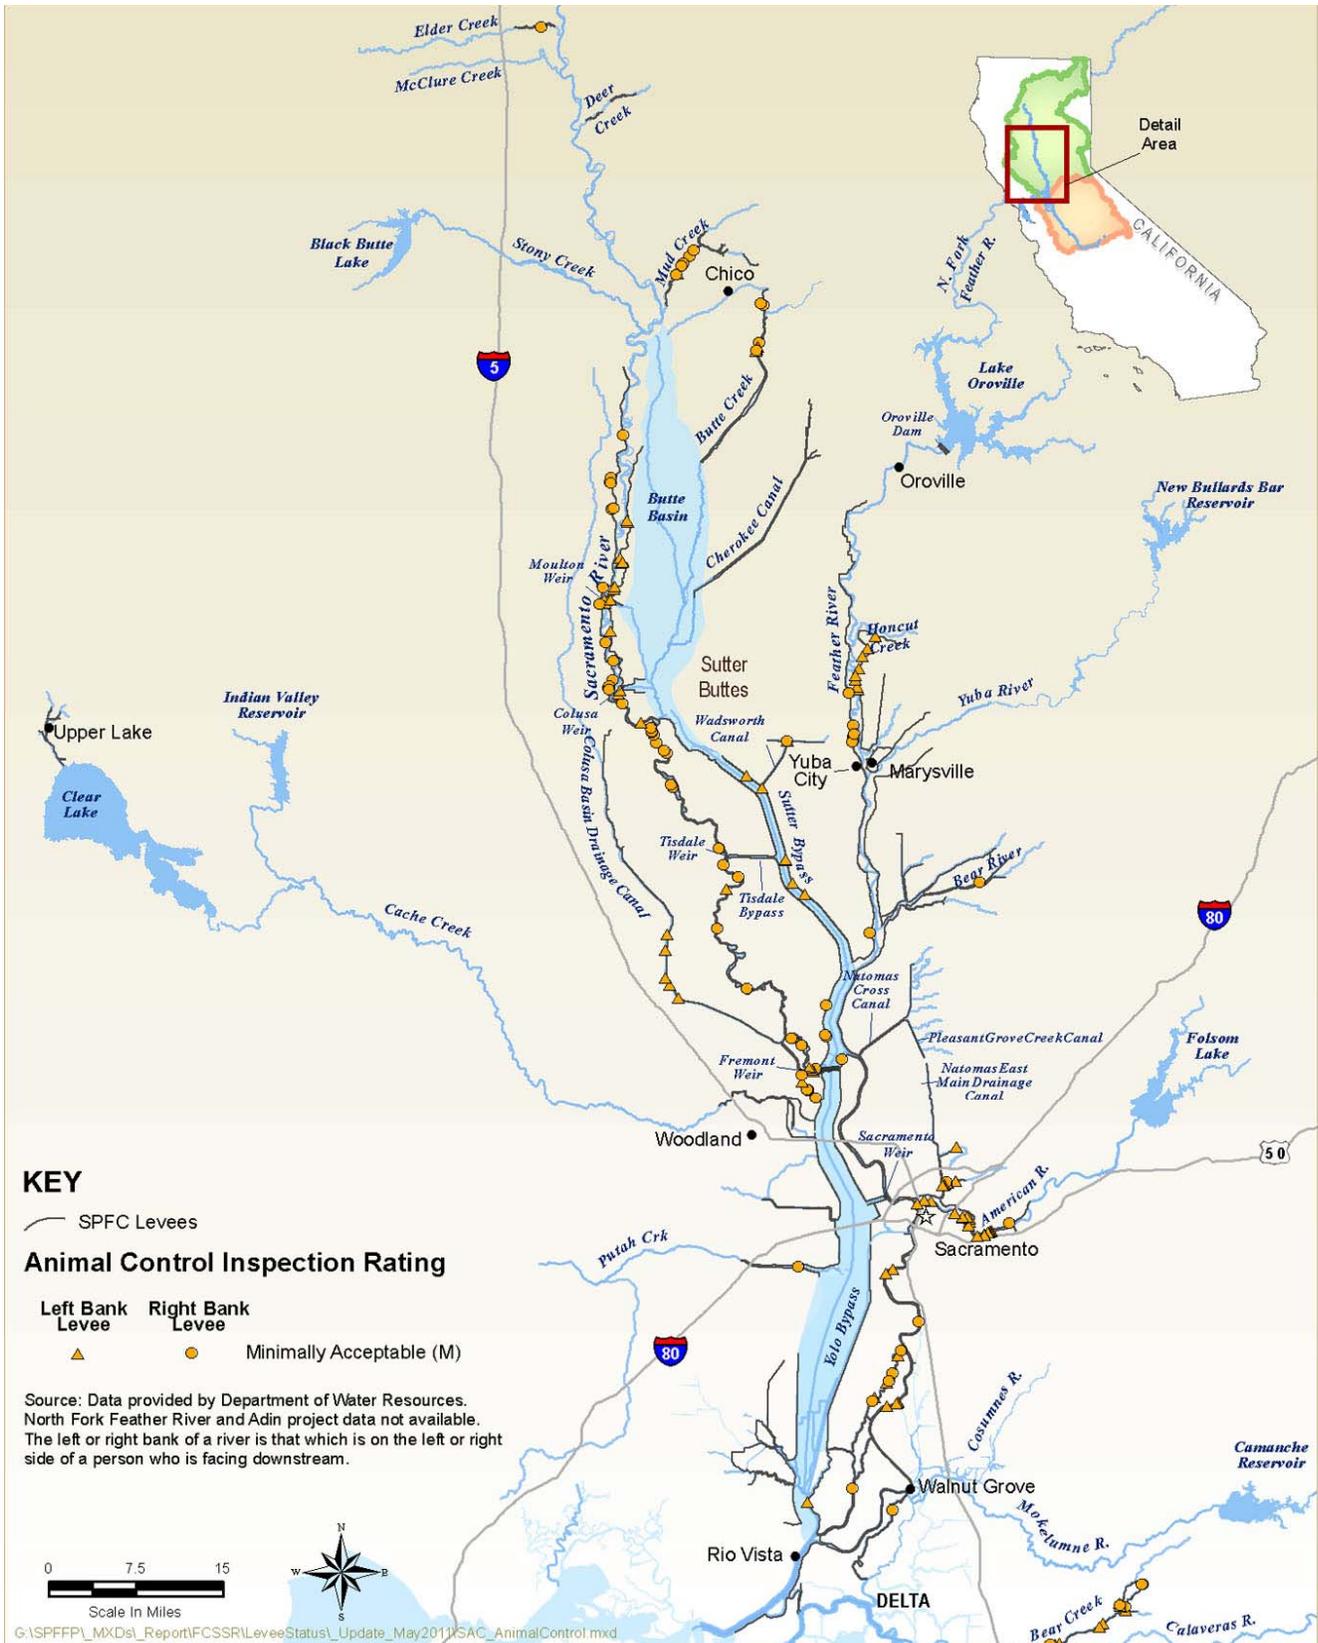
Figure A-32. 2009 Animal Control Inspection Ratings in Sacramento River Watershed

Animal control inspection ratings from the *2009 Annual Inspection Report* (DWR, 2010b) are shown on Figures A-32 and A-33 for the Sacramento and San Joaquin river watersheds, respectively. The inspection data show that several levees were given Minimally Acceptable ratings across the Sacramento River watershed, especially along the upper Sacramento River north of Fremont weir, American River, and Feather River. In the San Joaquin River watershed, Unacceptable and Minimally Acceptable ratings are prevalent throughout the watershed.
