# CENTRAL VALLEY FLOOD MANAGEMENT PLANNING PROGRAM

## Flood Control System Status Report

December 2011

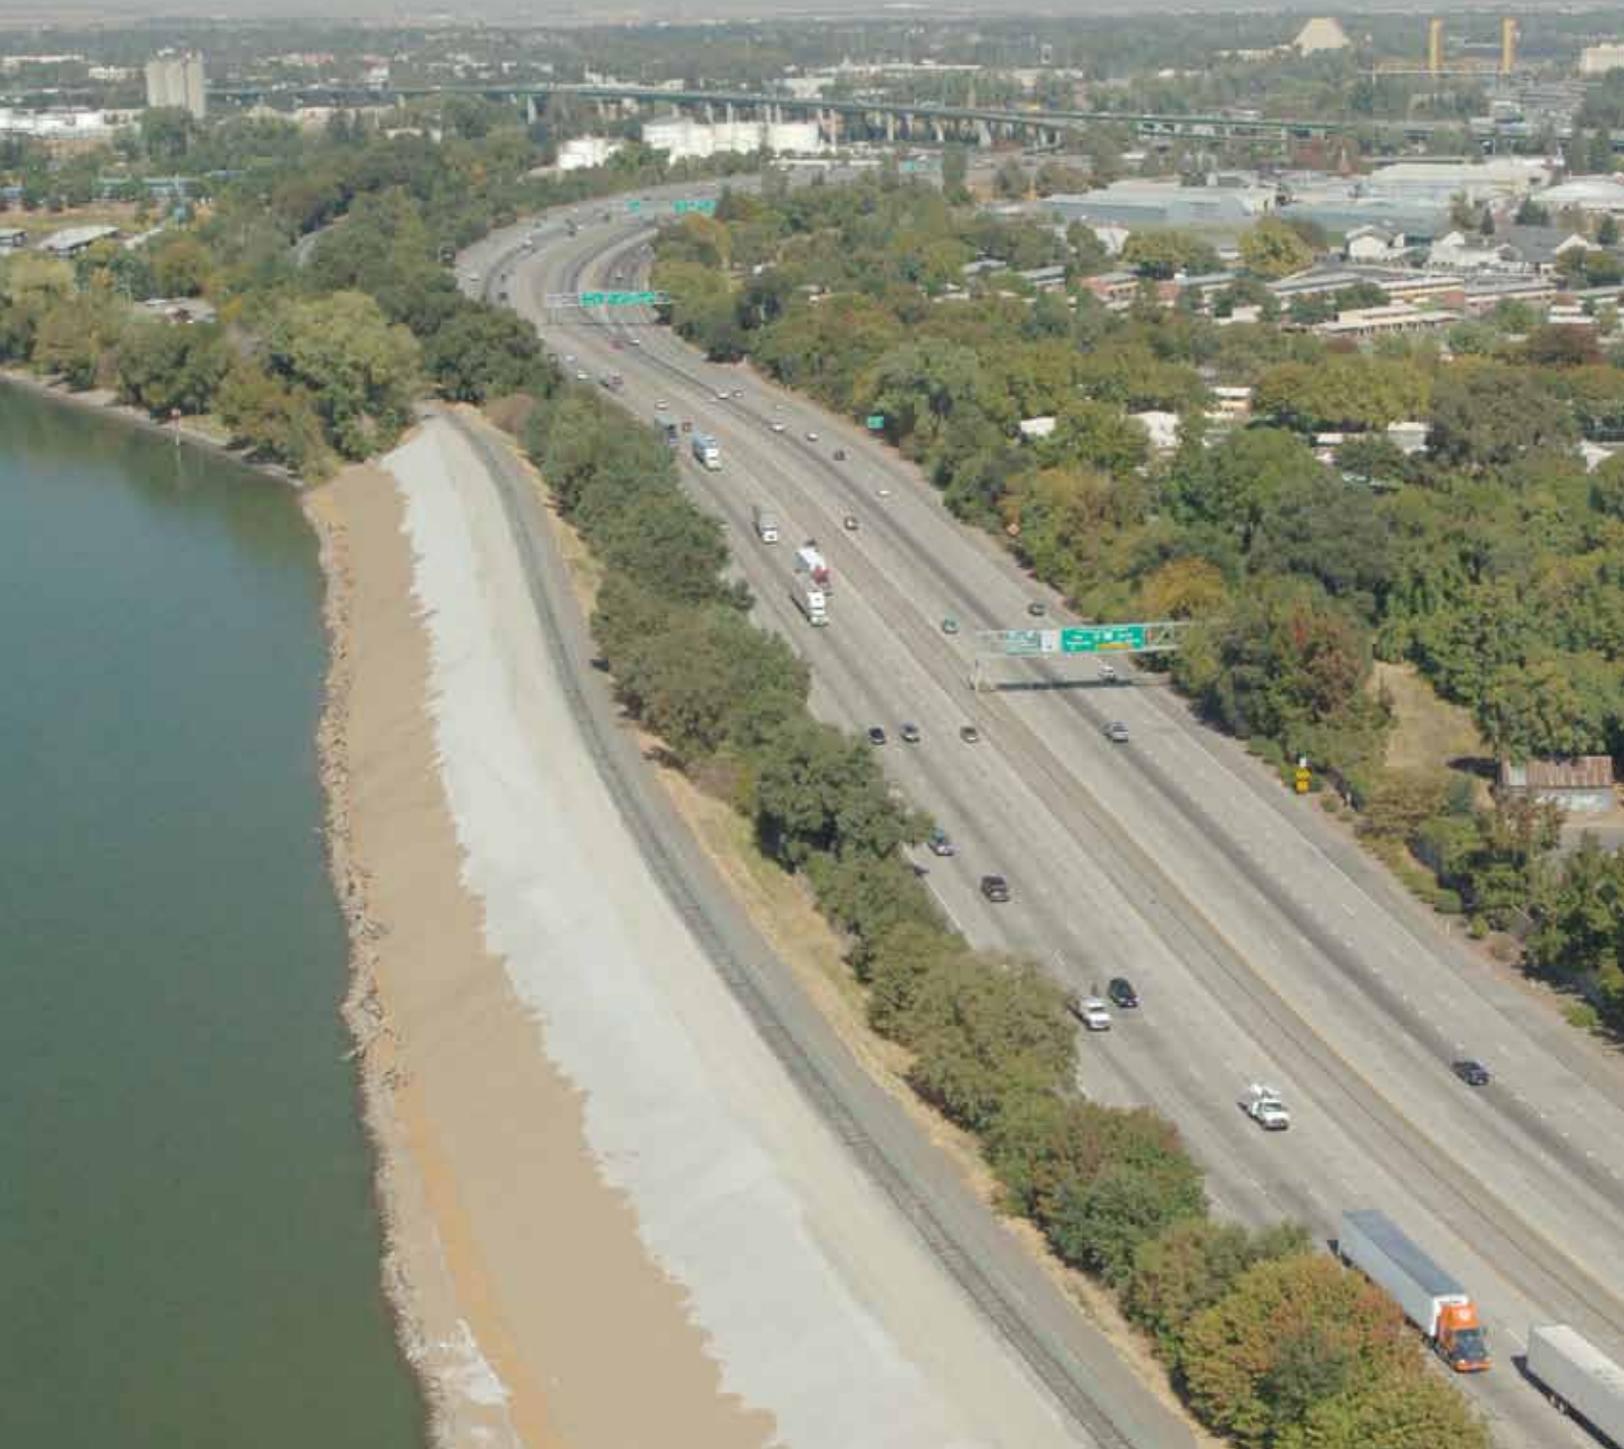
Critical levee repairs are being completed along the Sacramento River.

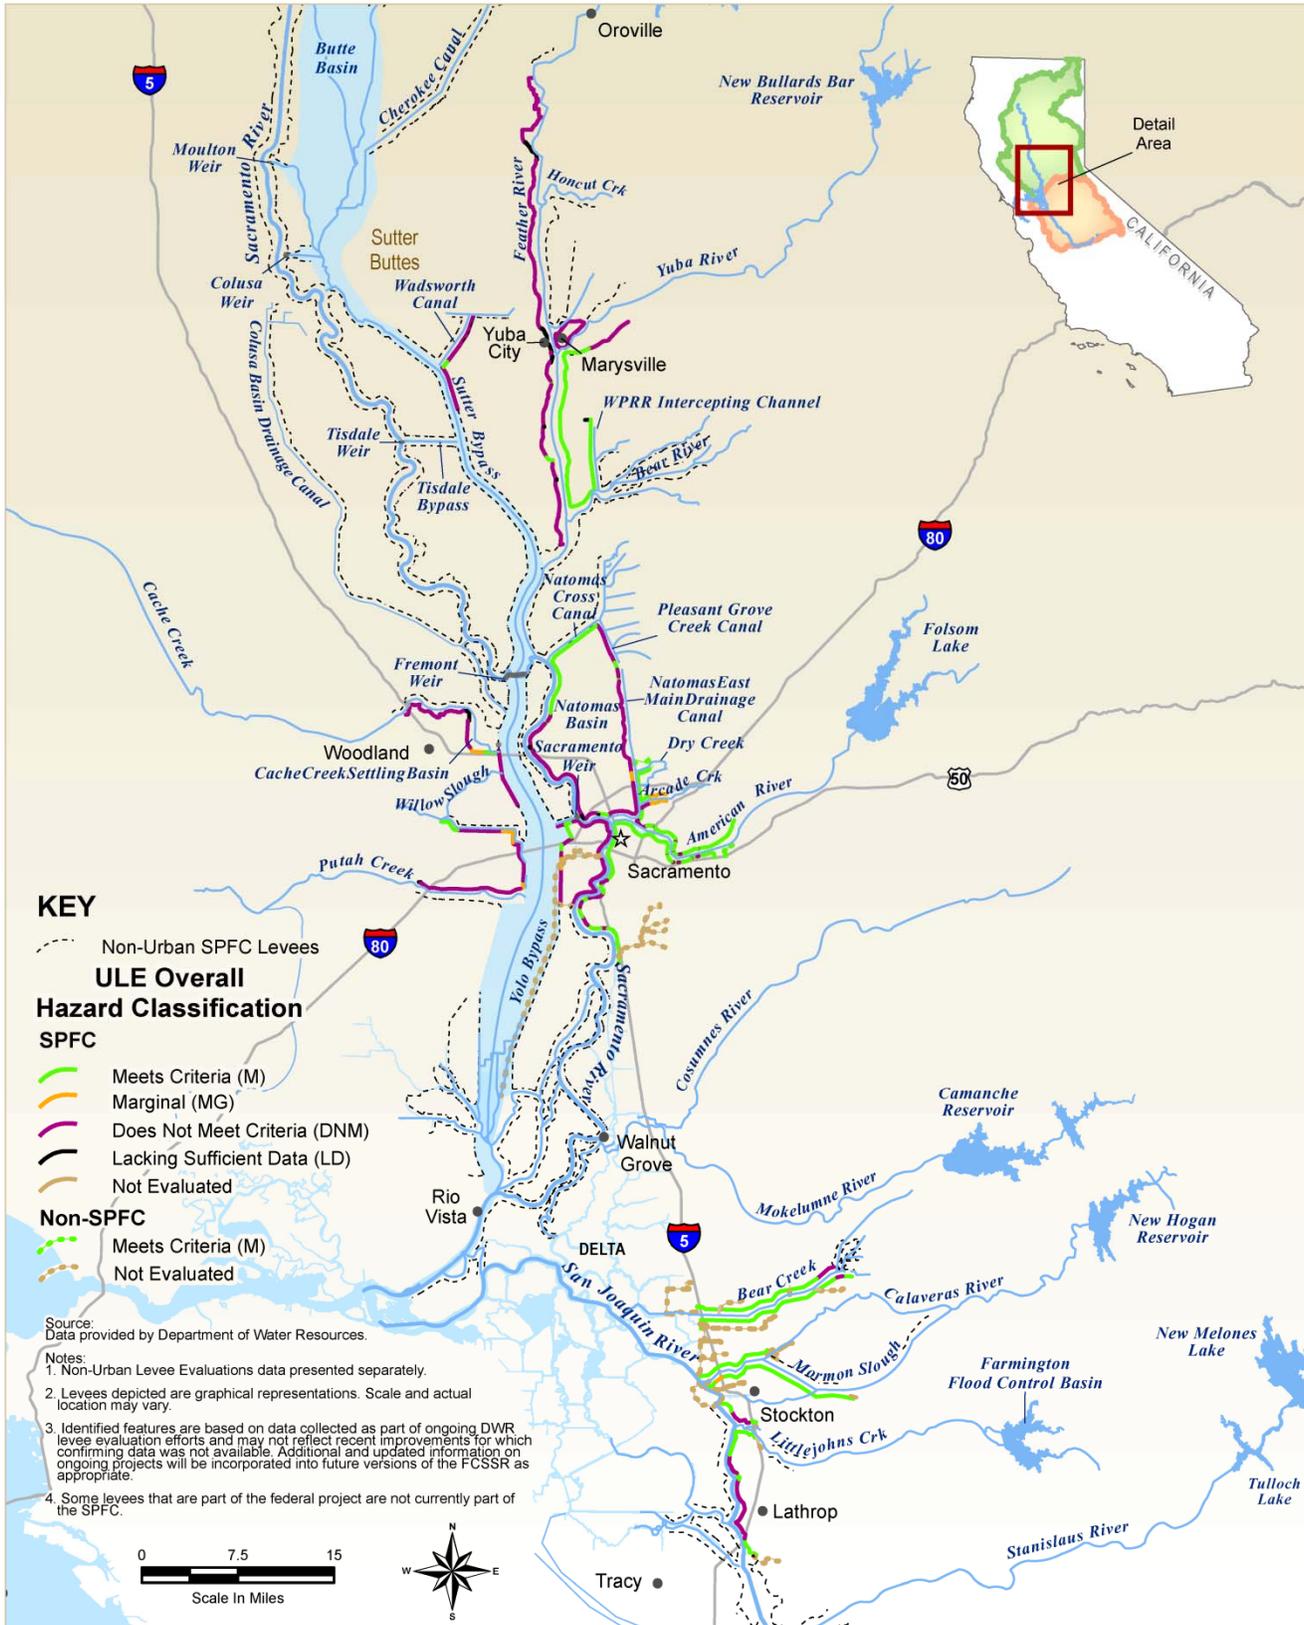
Figure 3-4. ULE Overall Hazard Classifications in Sacramento and San Joaquin River Watersheds

An overall classification was assigned to each ULE levee segment based on the collective performance for freeboard, steady state seepage, and steady state stability, as shown in Figure 3-3. For example, each ULE levee segment was assigned a hazard classification for each of the failure modes. If any of the hazard classifications is DNM (does not meet criteria), then the overall hazard classification is DNM. If any of the hazard classifications is LD (lacking sufficient data), then the overall hazard classification is LD. If all of the hazard classifications are M (meets criteria), then the overall hazard classification is M. One or more MGs result in an overall hazard classification of MG. Levee geometry classification was not included in the overall classification because the ULE geometry check was performed as a first step in an evaluation of erosion hazard that is not yet complete. ULE classifications do not reflect recent levee improvements for which geotechnical data are not available or have not been provided. When new geotechnical data become available, the data will be incorporated into future updates to this FCSSR.

Overall hazard classifications of SPFC ULE levee segments in the Sacramento River and San Joaquin river watersheds are shown in Figure 3-4.

ULE geometry check results were not considered in assignment of the ULE overall hazard classification in Figure 3-4.

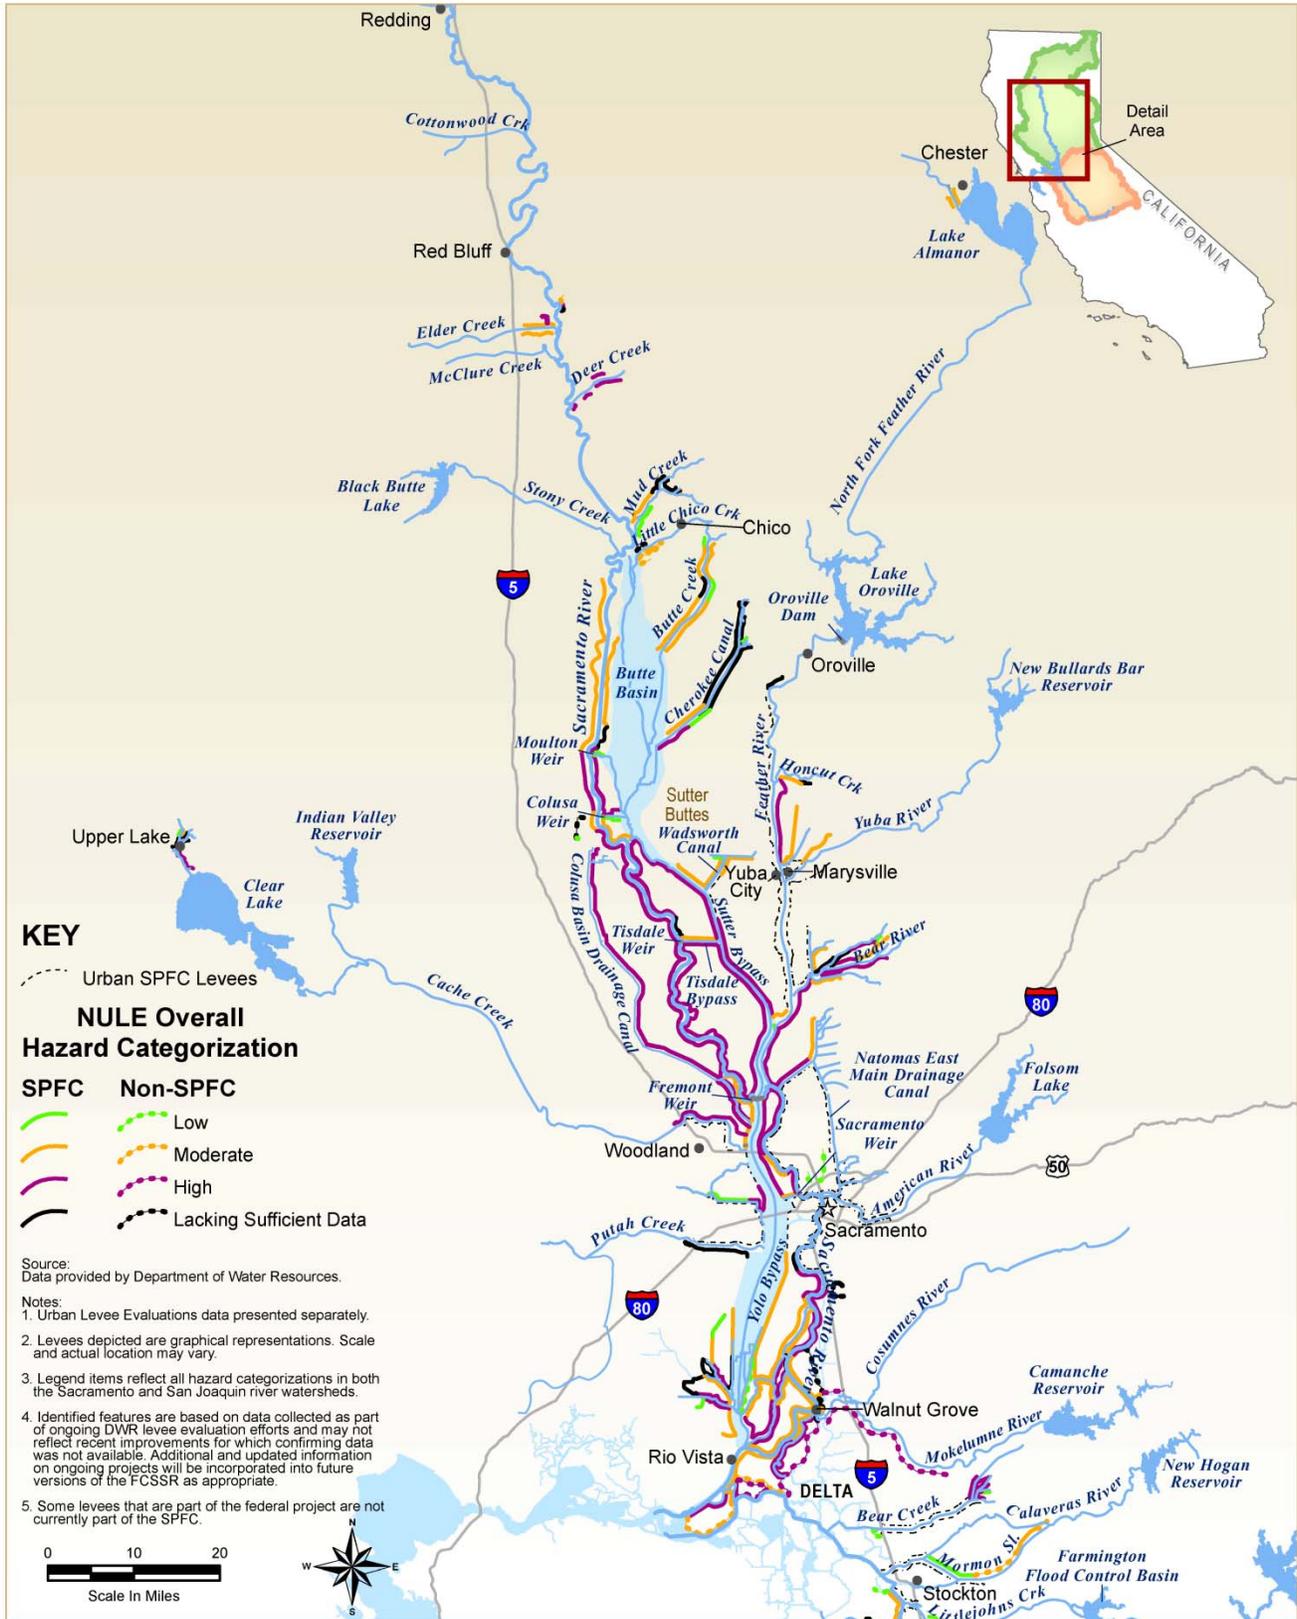
**Figure 3-6. North NULE Overall Hazard Categorizations in Sacramento River Watershed**

The *Geotechnical Assessment Report, North NULE Study Area* (DWR, 2011a), documents study methodology and results for NULE levees in the Sacramento River watershed. The overall hazard categorizations for SPFC and non-SPFC levees in the North NULE Study Area are shown in Figure 3-6. The *Geotechnical Assessment Report, South NULE Study Area* (DWR, 2011b), documents study methodology and results for NULE levees in the San Joaquin River watershed. The overall hazard categorizations for SPFC and non-SPFC levees in the South NULE Study Area are shown in Figure 3-7.

Overall, approximately three-fifths of NULE SPFC levees have a High hazard category at the assessment water surface elevation. Only about one-sixteenth of the NULE SPFC levees have a Low hazard category. In the Sacramento River watershed, NULE SPFC levees categorized as Low are primarily along tributaries; none of the NULE SPFC levees along the Sacramento River are categorized as Low. In the San Joaquin River watershed, NULE levees categorized as Low are primarily along tributaries, with some short segments along the San Joaquin River.

NULE geometry check results were not considered in the assignment of an NULE overall hazard categorization in Figure 3-6 and Figure 3-7. Instead, other levee geometry parameters, such as head-to-levee base-width ratio, levee height, and levee landside slope angle, were considered in assignment of NULE under-seepage, through-seepage and stability hazard categorizations, which, in turn, impacted the NULE overall hazard categorization in Figure 3-6 and Figure 3-7.

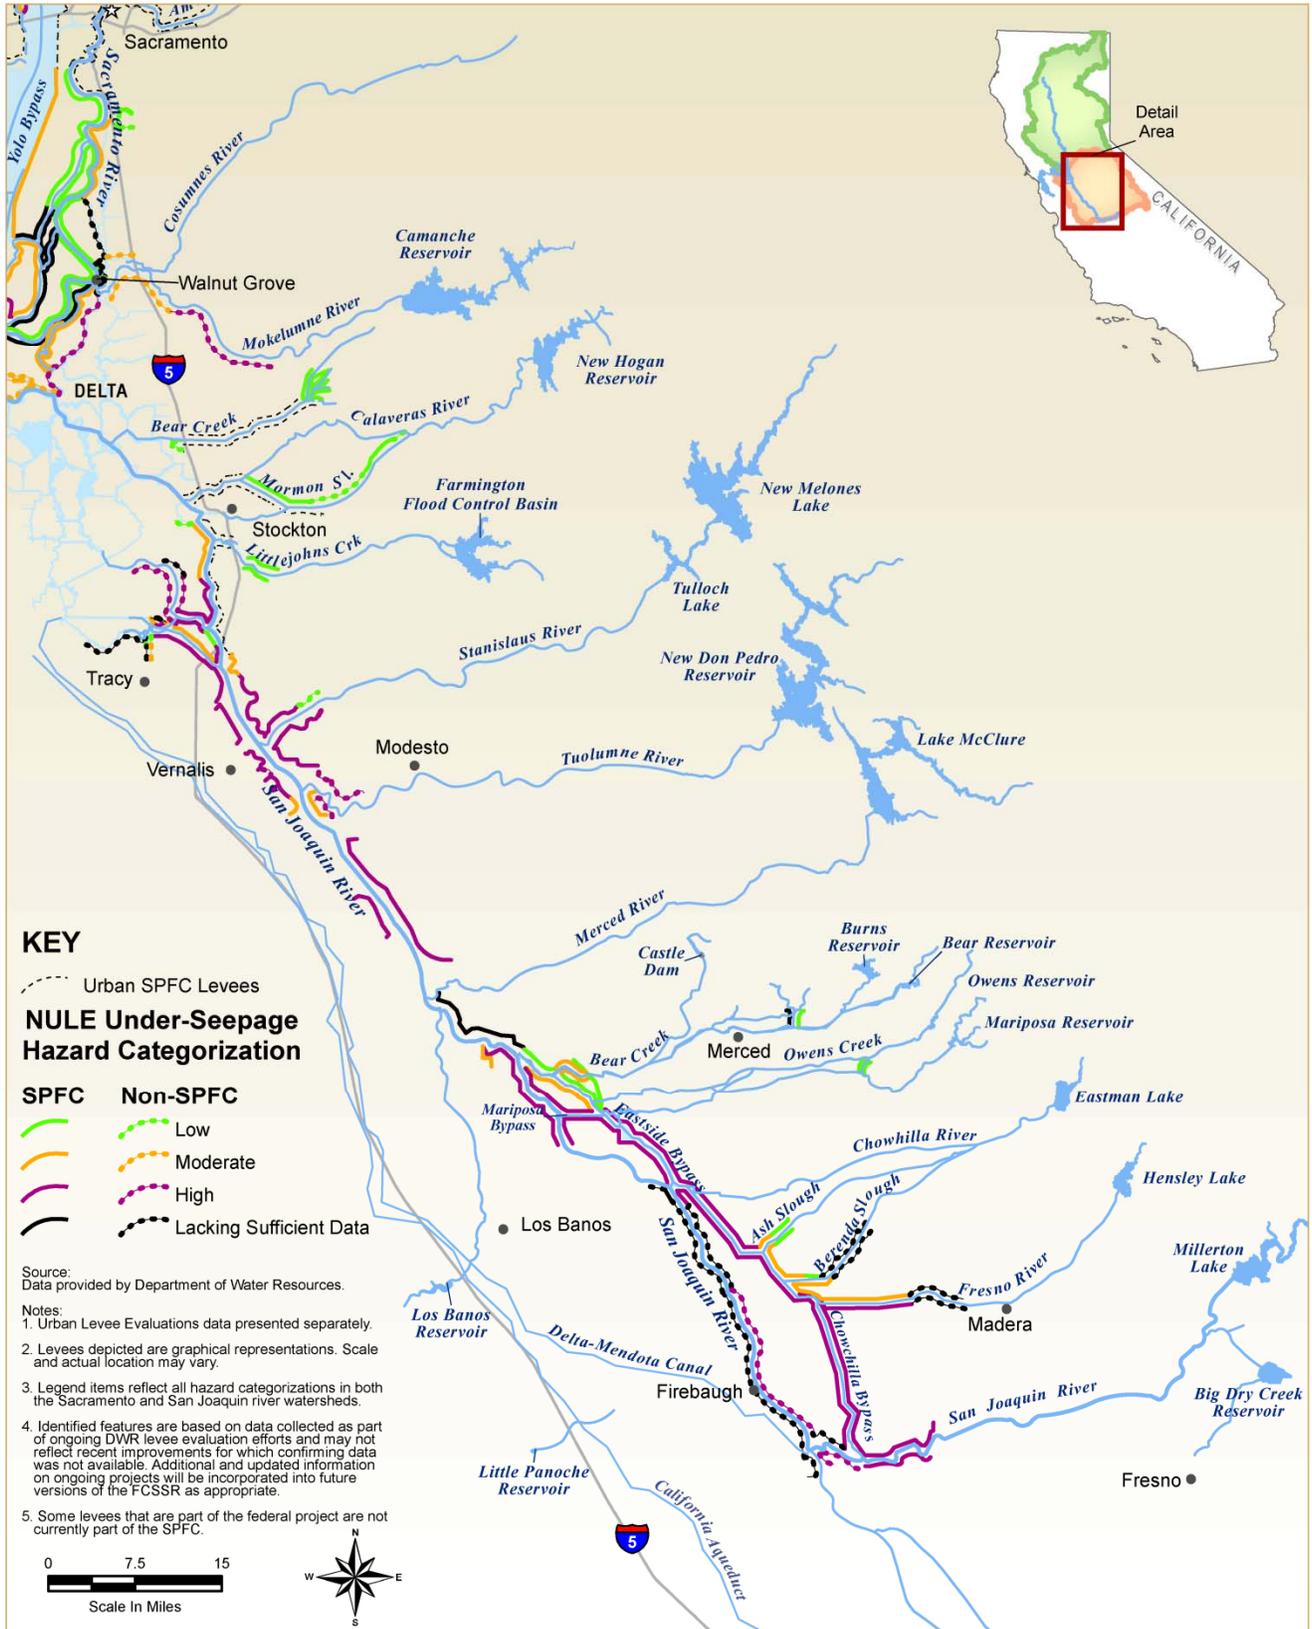
**Figure 4-7. NULE Under-Seepage Hazard Categorizations in San Joaquin River Watershed**

Results of the NULE under-seepage and through-seepage hazard categorizations are shown in Figures 4-6 through 4-9. Figures 4-6 and 4-7 show the under-seepage hazard categorizations for NULE levees in the Sacramento and San Joaquin river watersheds, respectively. Figures 4-6 and 4-7 show that approximately one-third of SPFC NULE levees in the Sacramento River watershed and almost two-thirds in the San Joaquin River watershed have a high under-seepage hazard. Figures 4-8 and 4-9 show through-seepage hazard categorizations for NULE levees in the two watersheds. In general, through-seepage is less prevalent than under-seepage; approximately one-eighth of SPFC NULE levees in the Sacramento River watershed and approximately half in the San Joaquin River watershed have a high through-seepage hazard.

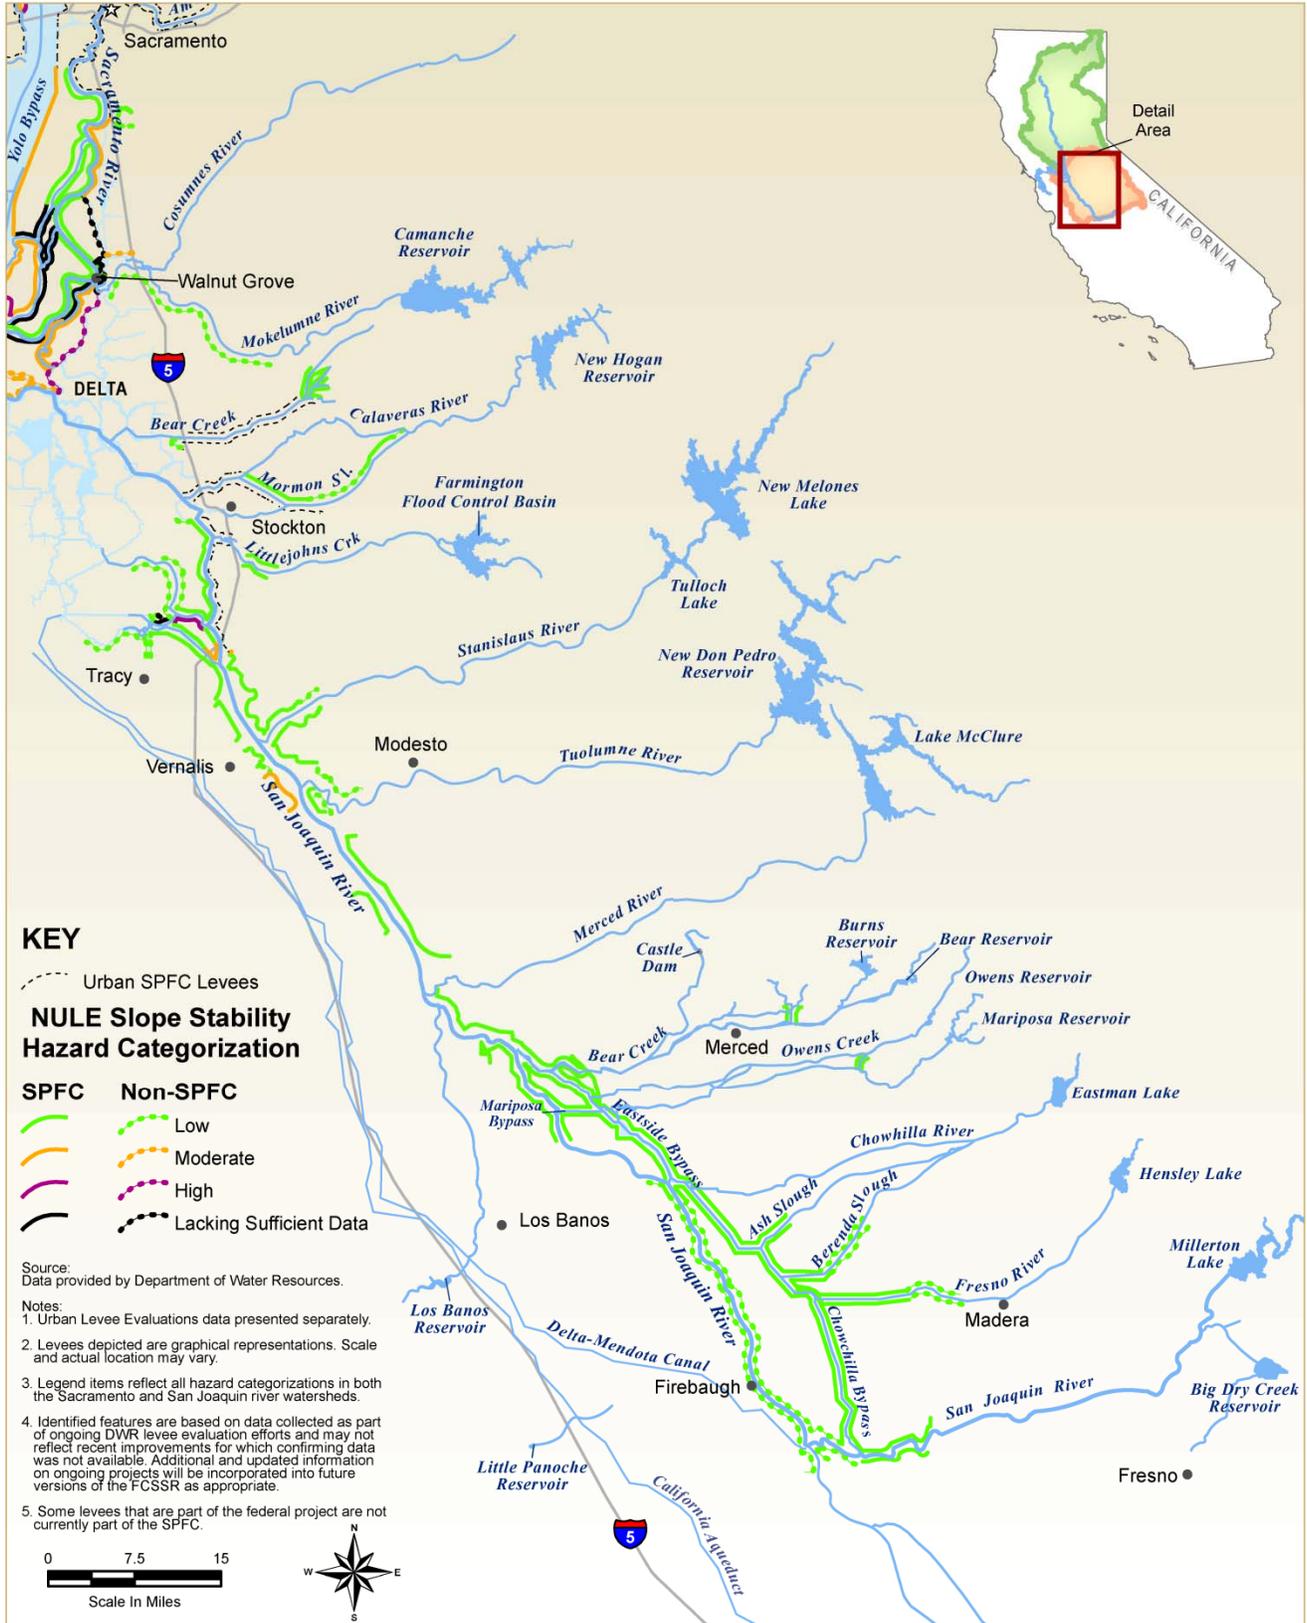
**Figure 4-12. NULE Slope Stability Hazard Categorizations in San Joaquin River Watershed**

Slope stability hazard categories are shown in Figures 4-11 and 4-12. As shown, there is generally a higher slope stability hazard for levees in the Sacramento River watershed compared to the San Joaquin River watershed. Approximately one-eighth of SPFC NULE levees in the Sacramento River watershed and 1 percent in the San Joaquin River watershed have a high slope stability hazard.

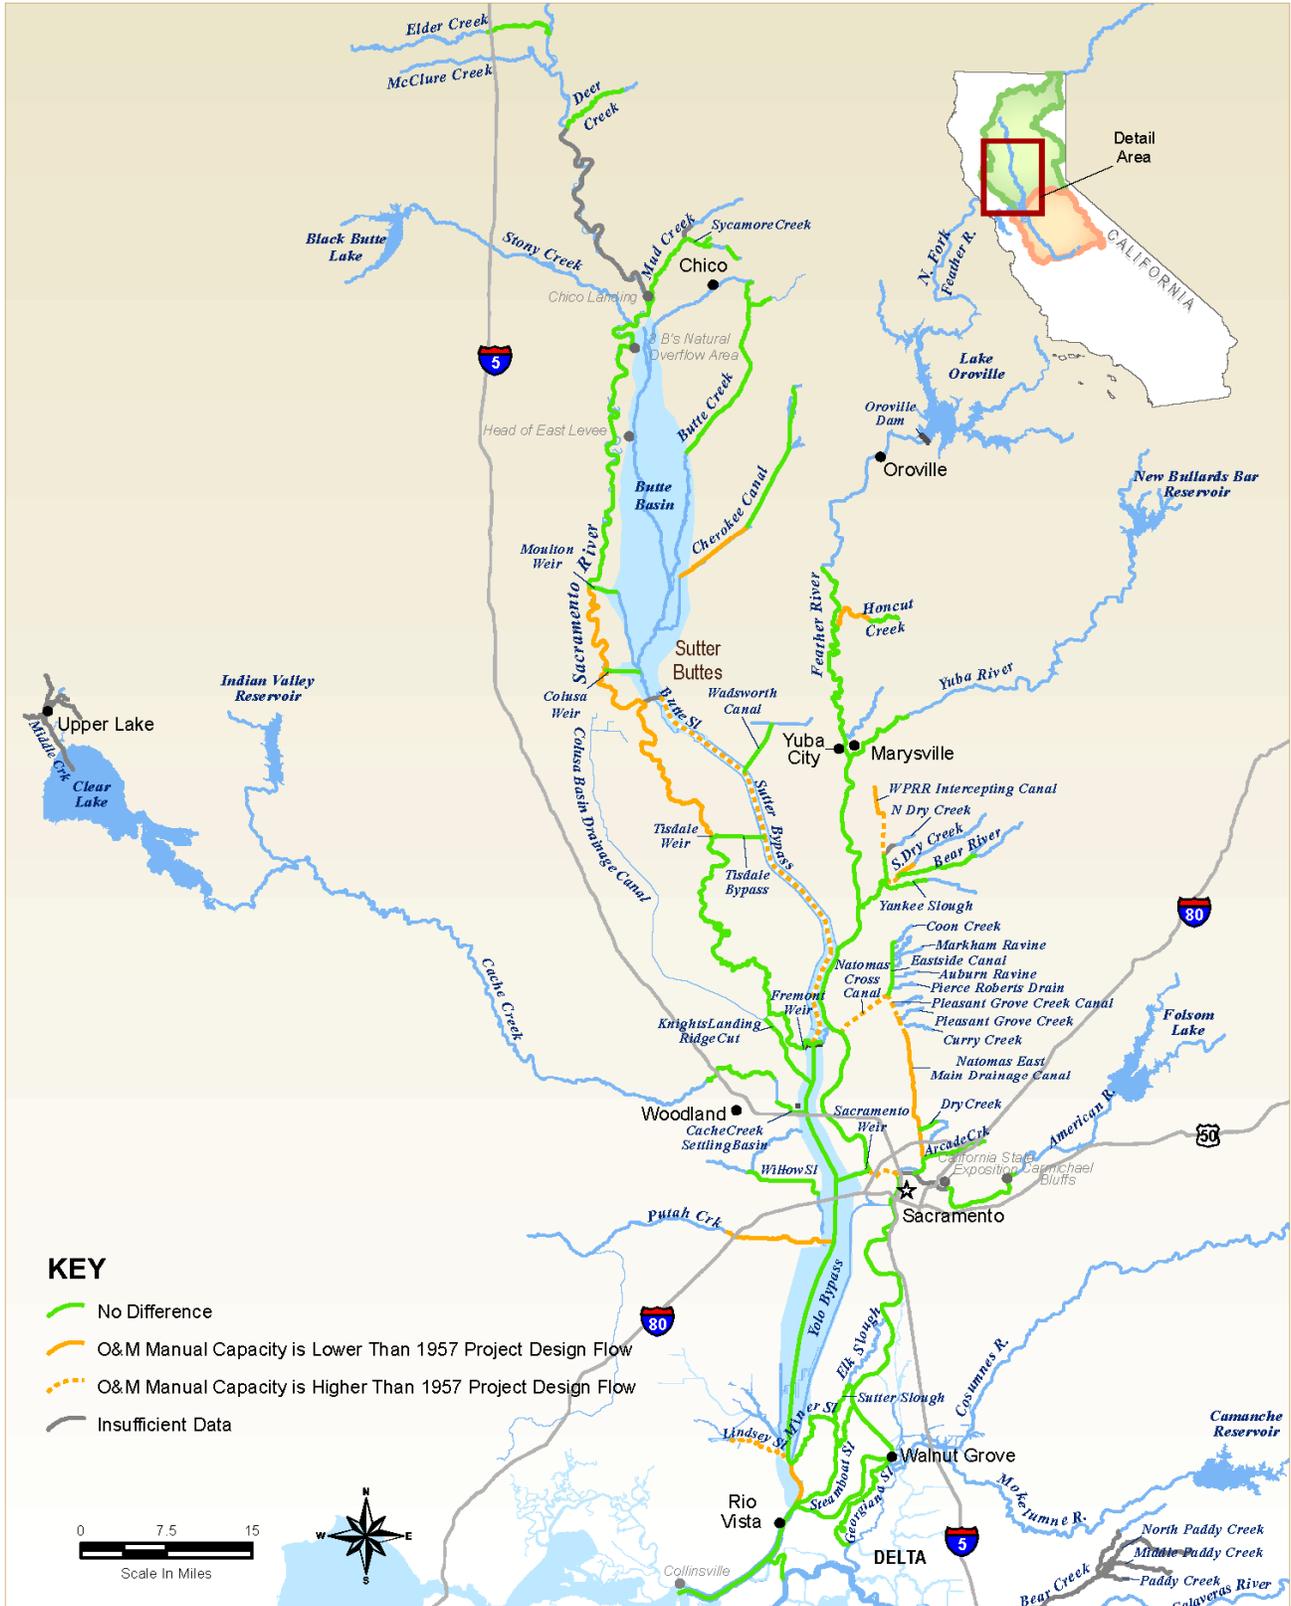
**Figure 5-1. Differences Between O&M Manual Design Capacities and Design Profile Flows in Sacramento River Watershed**

Differences between design capacities reported in O&M manuals and flows associated with the design profiles shown in Figures 5-1 and 5-2 demonstrate the need to resolve discrepancies in some locations. Potential inadequate channel conveyance capacities are shown in Figures 5-3 and 5-4.

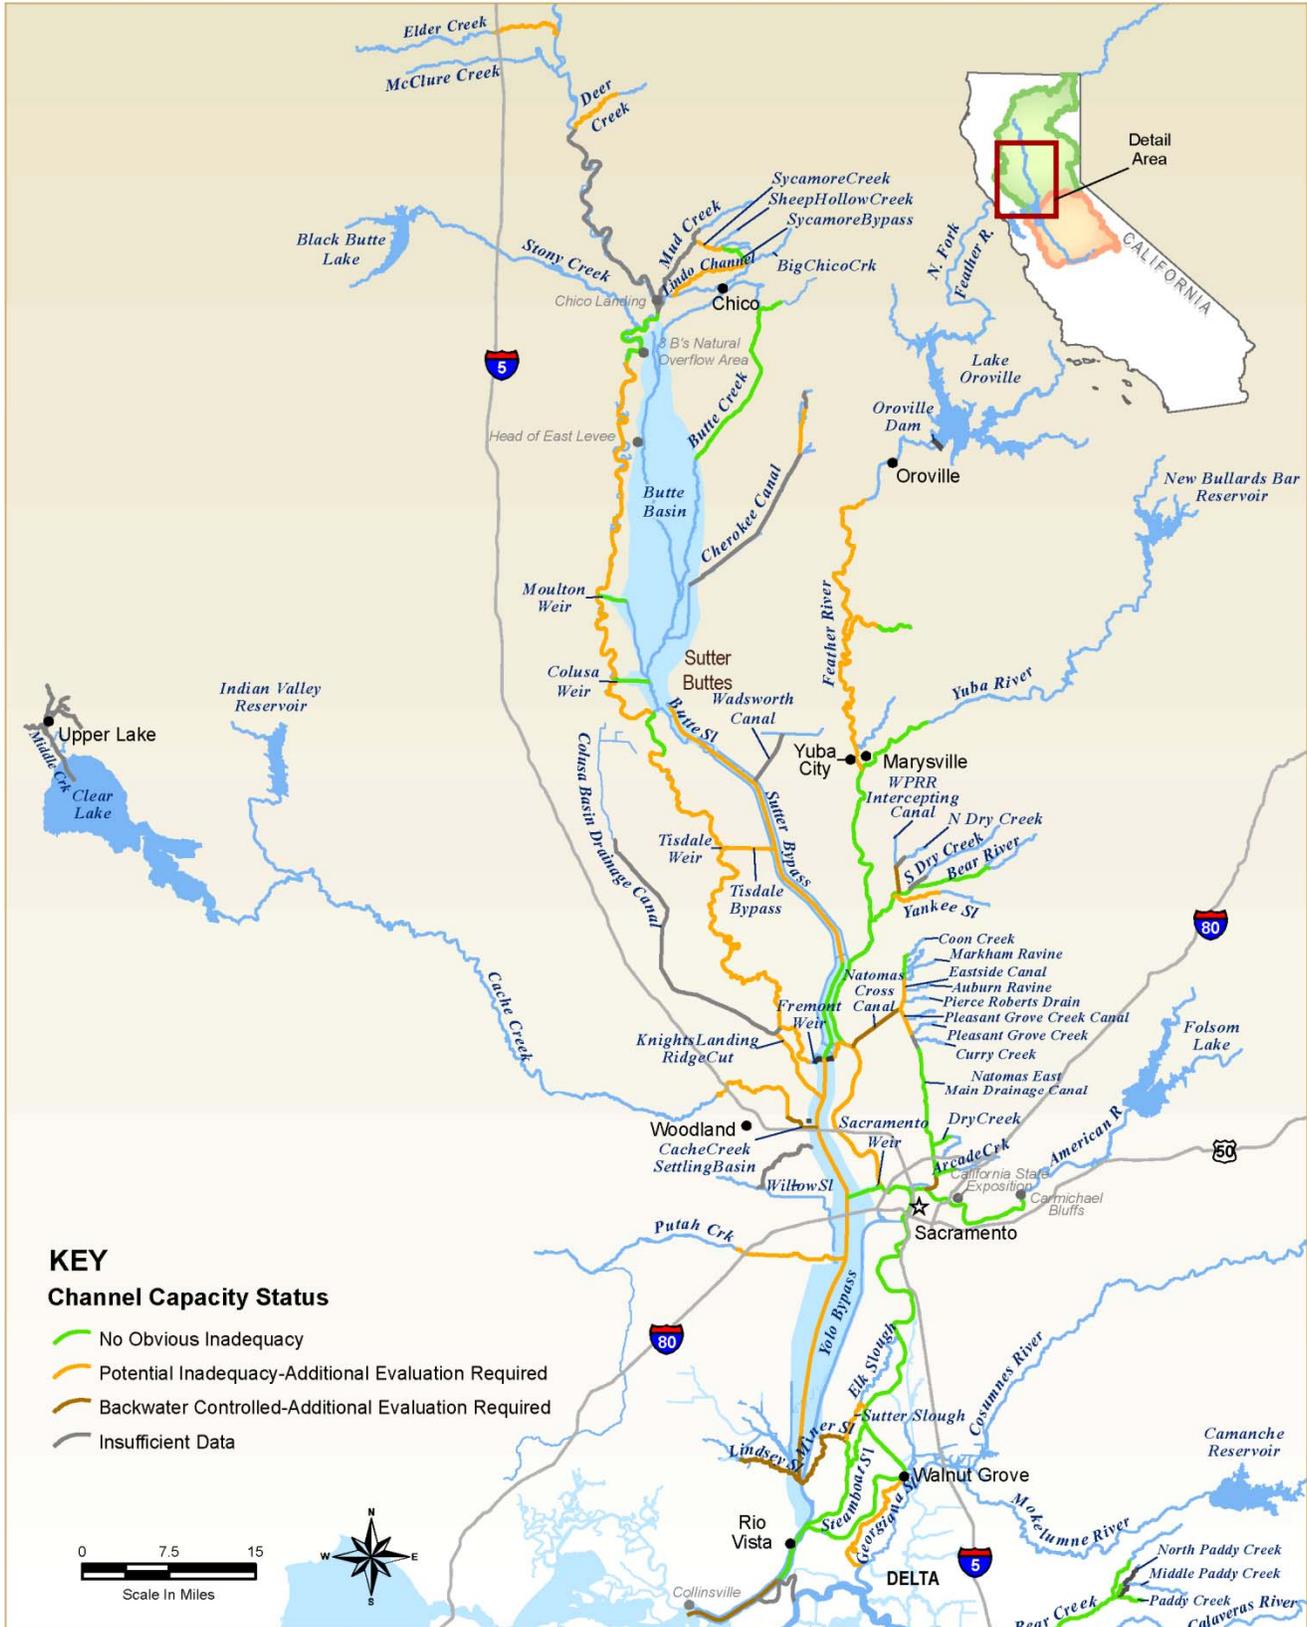
Figure 5-3. Channel Capacity Status in Sacramento River Watershed

For the Sacramento River watershed, approximately four-ninths of the channels show a potential capacity inadequacy and need for additional evaluation, and data are insufficient for approximately one-fifth of the channels. In general, approximately three-fifths of the channels in the San Joaquin River watershed show a potential capacity inadequacy and need for additional evaluation, and data are insufficient for one-eighth. These results will be refined as systemwide and project-specific hydraulic modeling efforts progress. Appendix B, Section B-1, contains tables of the results shown in Figures 5-3 and 5-4.

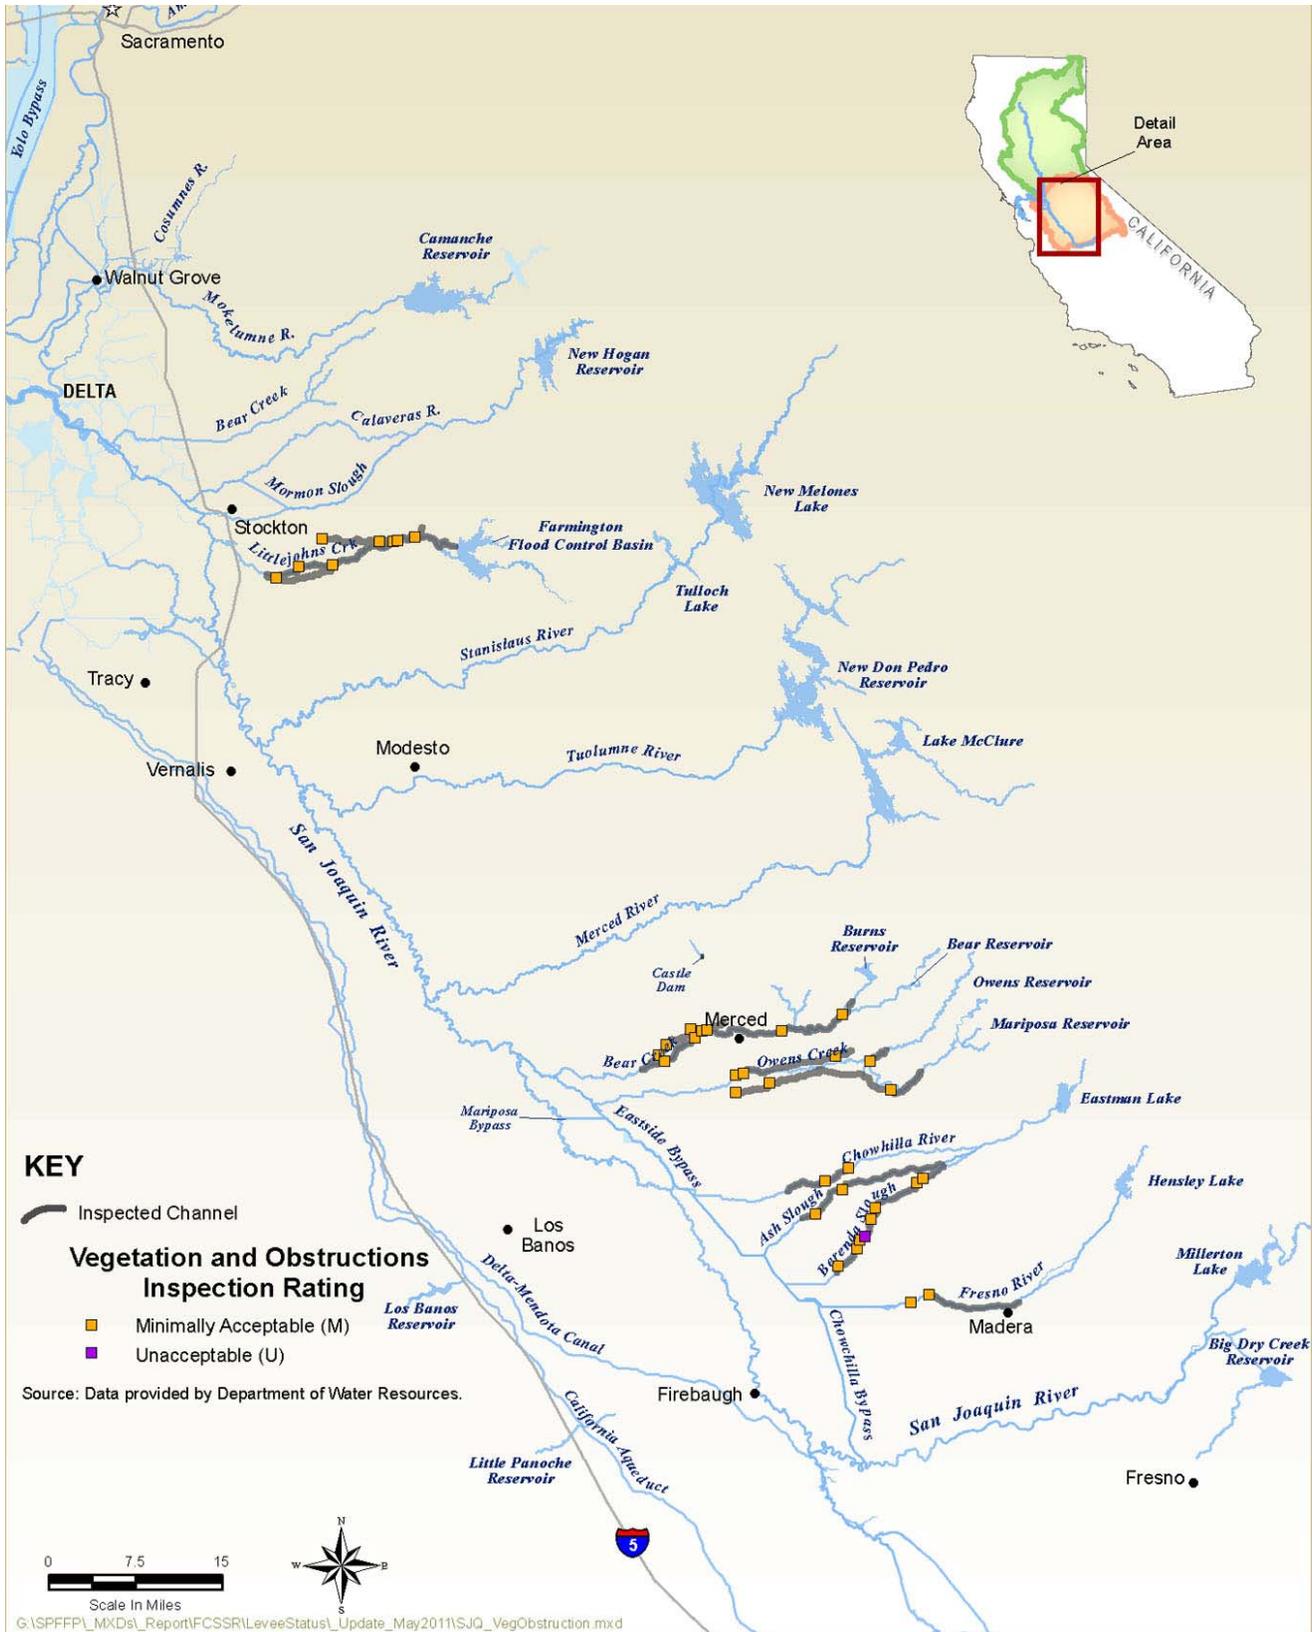
Figure 5-6. 2009 Channel Vegetation Inspection Ratings in San Joaquin River Watershed

Channel inspection ratings for vegetation from the *2009 Inspection Report of the Central Valley State-Federal Flood Protection System* (DWR, 2010b) are shown in Figures 5-5 and 5-6 for channels maintained by DWR and other maintaining agencies. Of the 186 miles of SPFC channels inspected by DWR, one location was rated Unacceptable (Berenda Slough, downstream from Avenue 21) and 54 locations were rated Minimally Acceptable for channel vegetation. Additional vegetation problems may be present in channels not inspected by DWR.

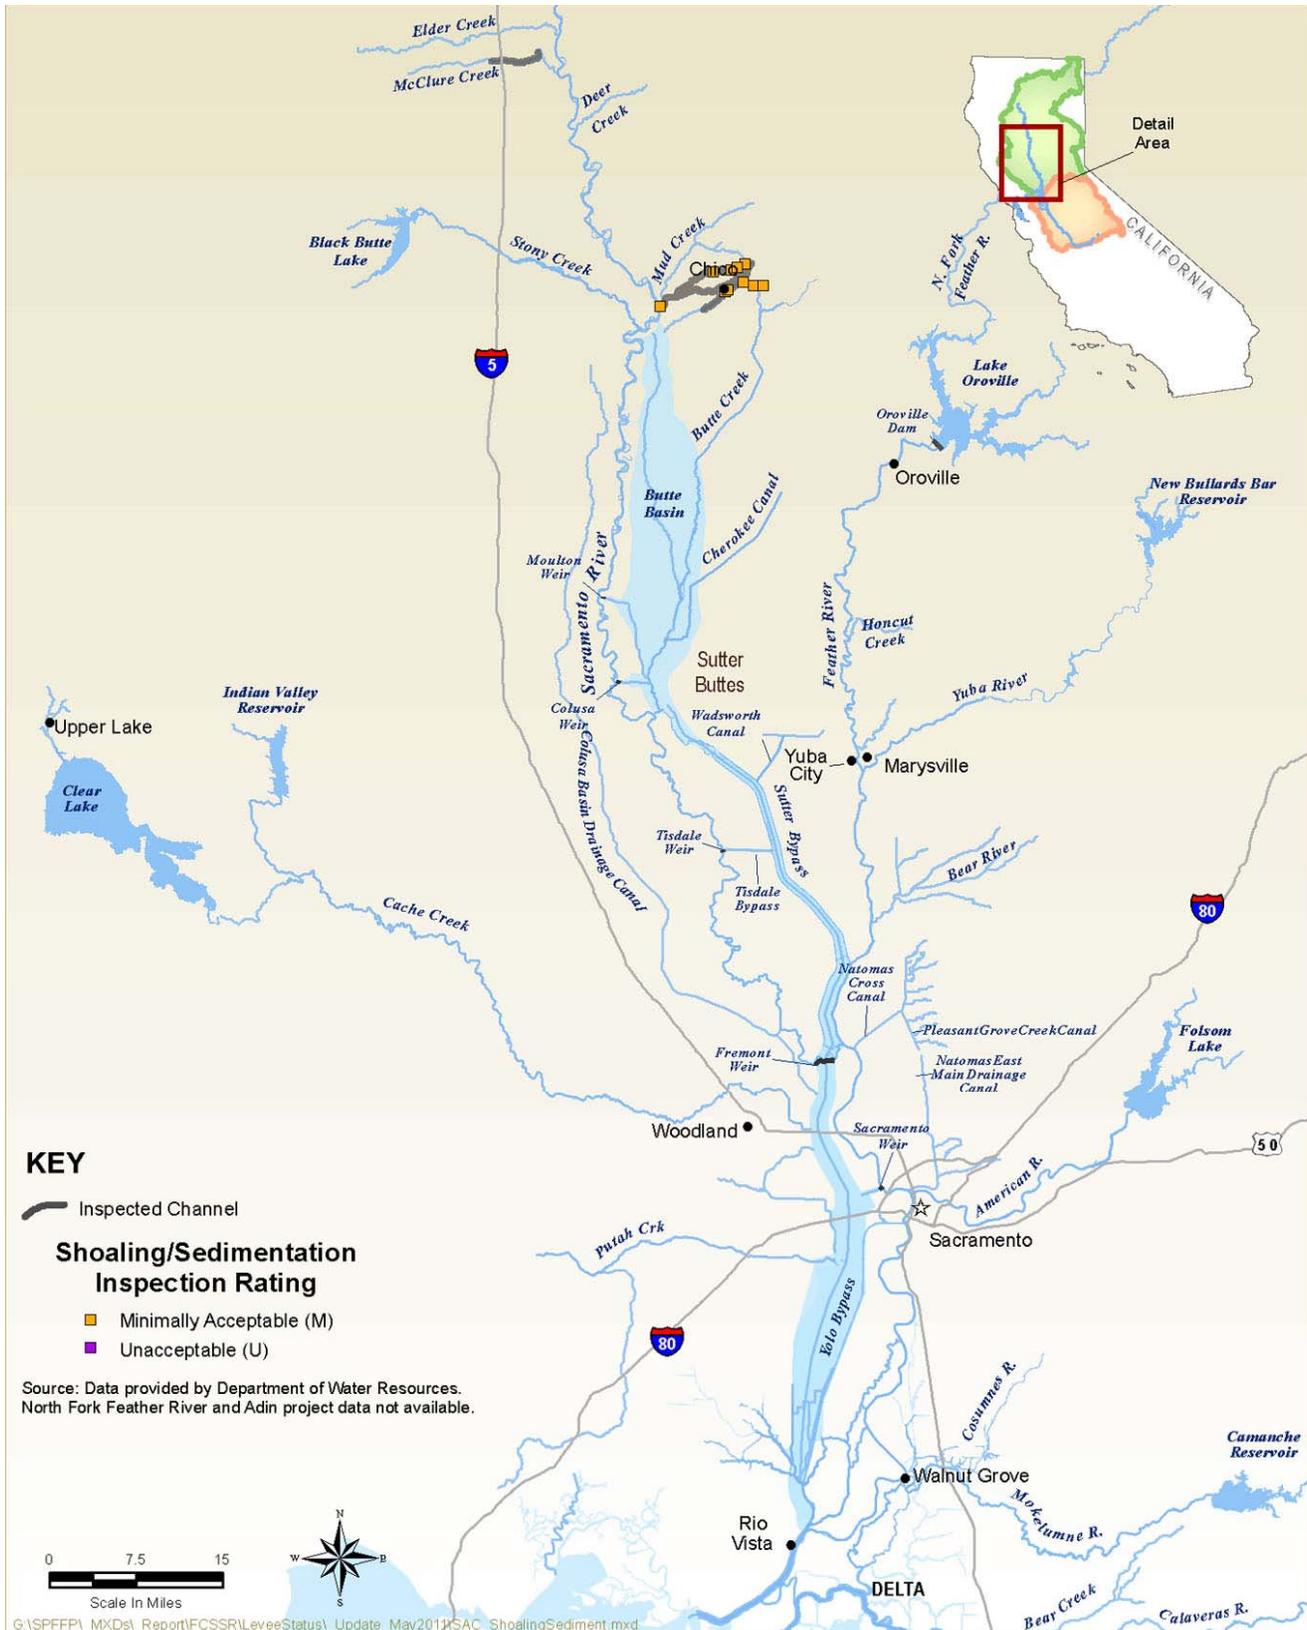
**Figure 5-7. 2009 Channel Shoaling/Sedimentation Inspection Ratings in Sacramento River Watershed**

Shoaling and sedimentation channel inspection ratings from the *2009 Inspection Report of the Central Valley State-Federal Flood Protection System* (DWR, 2010b) are shown in Figures 5-7 and 5-8. Of the 186 miles of SPFC channels inspected by DWR, one location was rated Unacceptable (Berenda Slough, downstream and upstream from Avenue 21) and 23 locations were rated Minimally Acceptable for shoaling and sedimentation. Additional channel sedimentation problems may exist in areas not inspected by DWR.
