# CENTRAL VALLEY FLOOD MANAGEMENT PLANNING PROGRAM

## Flood Control System Status Report

December 2011

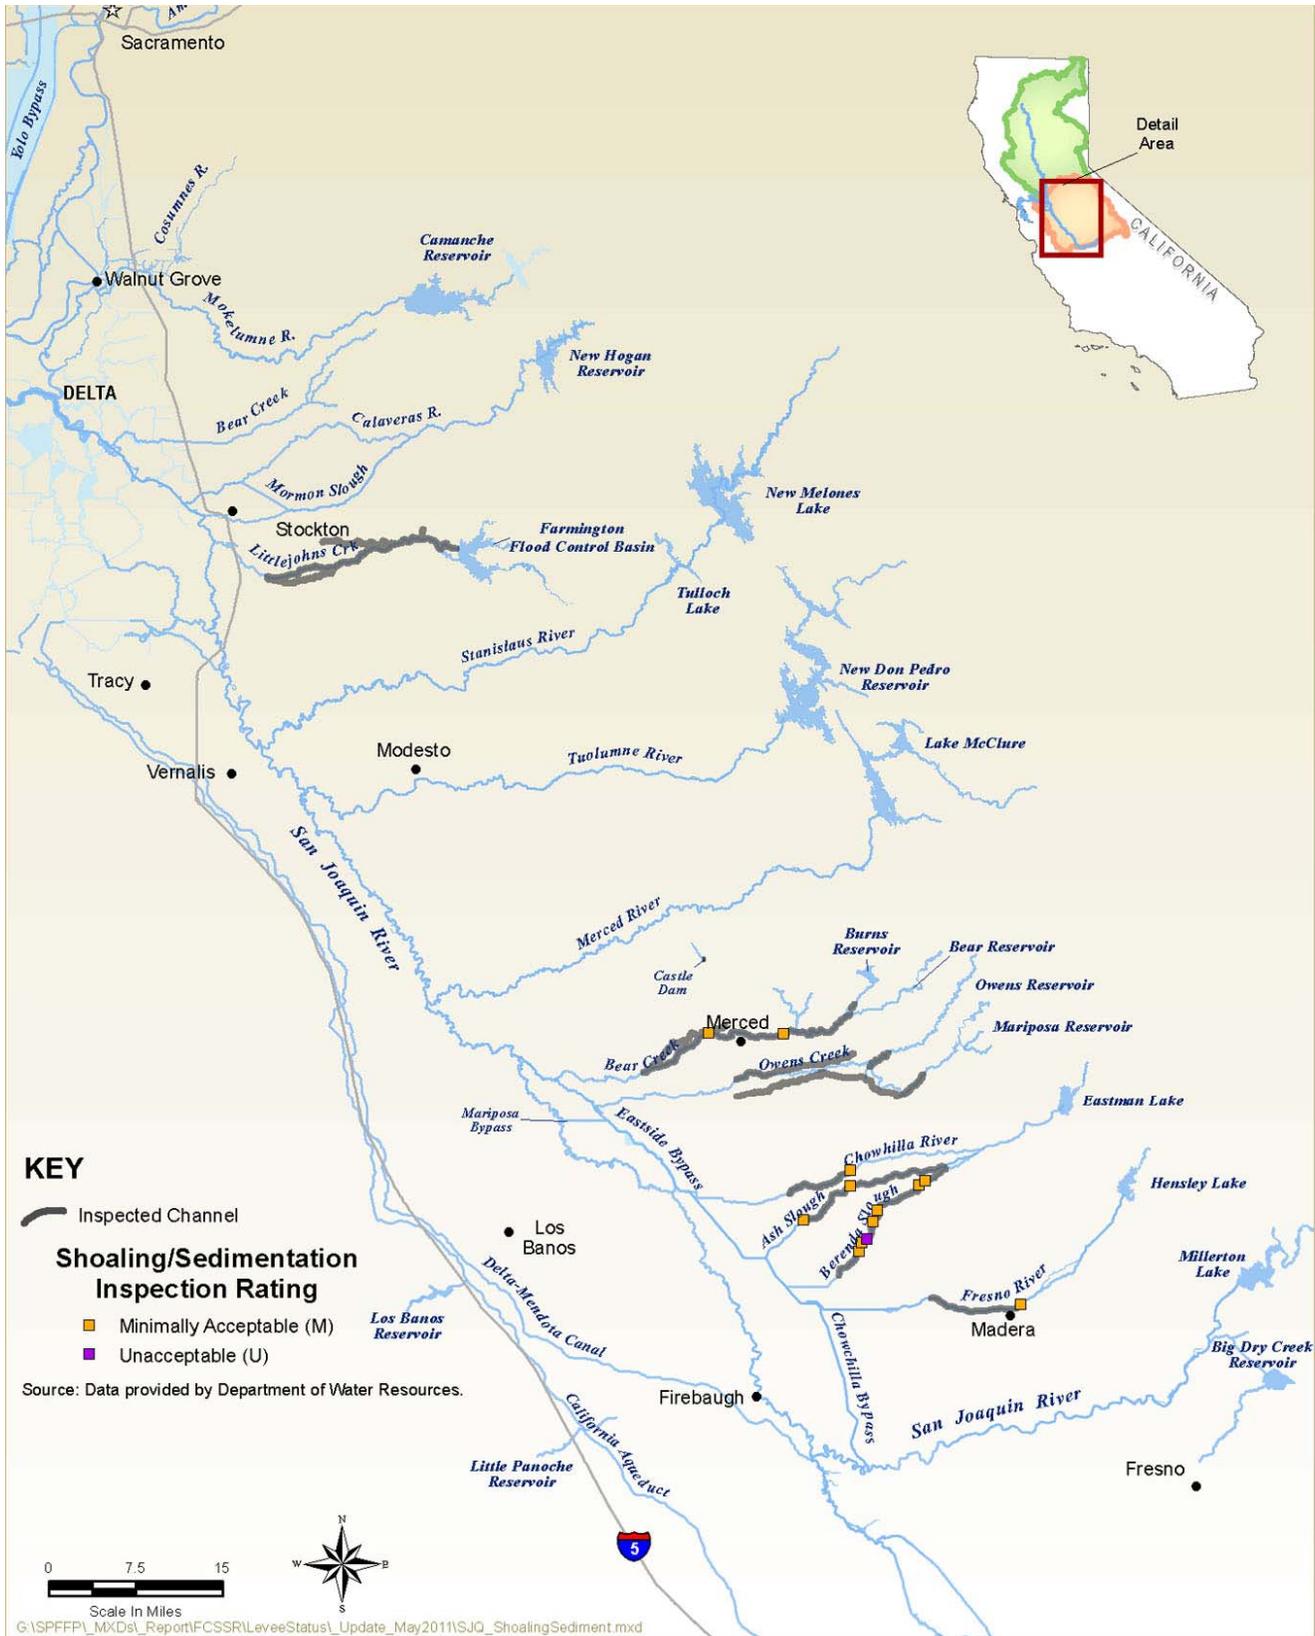
**Figure 5-8. 2009 Channel Shoaling/Sedimentation Inspection Ratings in San Joaquin River Watershed**

Shoaling and sedimentation channel inspection ratings from the *2009 Inspection Report of the Central Valley State-Federal Flood Protection System* (DWR, 2010b) are shown in Figures 5-7 and 5-8. Of the 186 miles of SPFC channels inspected by DWR, one location was rated Unacceptable (Berenda Slough, downstream and upstream from Avenue 21) and 23 locations were rated Minimally Acceptable for shoaling and sedimentation. Additional channel sedimentation problems may exist in areas not inspected by DWR.

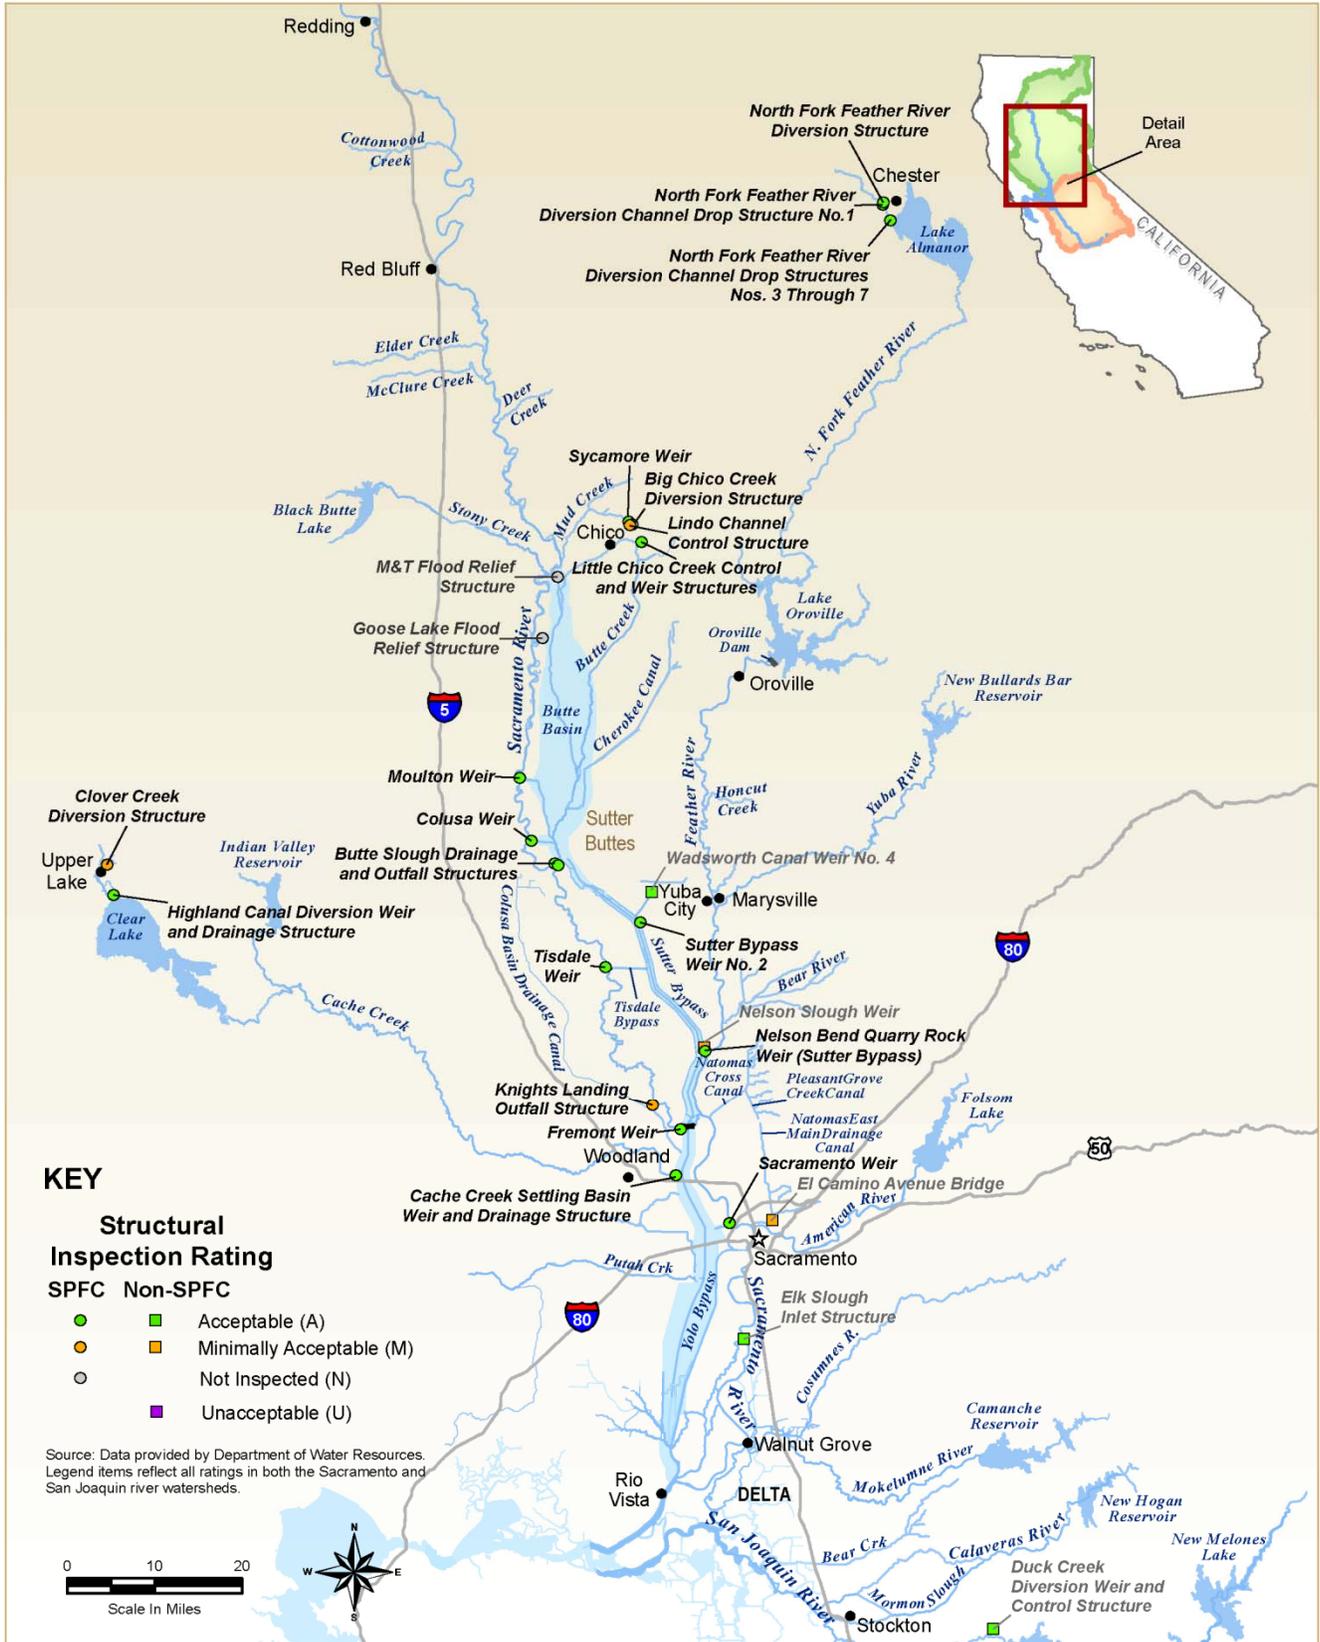
Figure 6-1. Hydraulic Structures – Structural Conditions in Sacramento River Watershed

Hydraulic structure conditions observed during annual inspections in 2009 (DWR, 2010b) are presented in Figures 6-1 through 6-8 for the Sacramento and San Joaquin river watersheds. Tabular results summarizing the Minimally Acceptable and Unacceptable inspection ratings for SPFC and non-SPFC hydraulic structures are shown in Table 6-4.

Ongoing and planned remedial actions and ongoing actions to improve future evaluations are summarized in Appendix C, Section C-1.

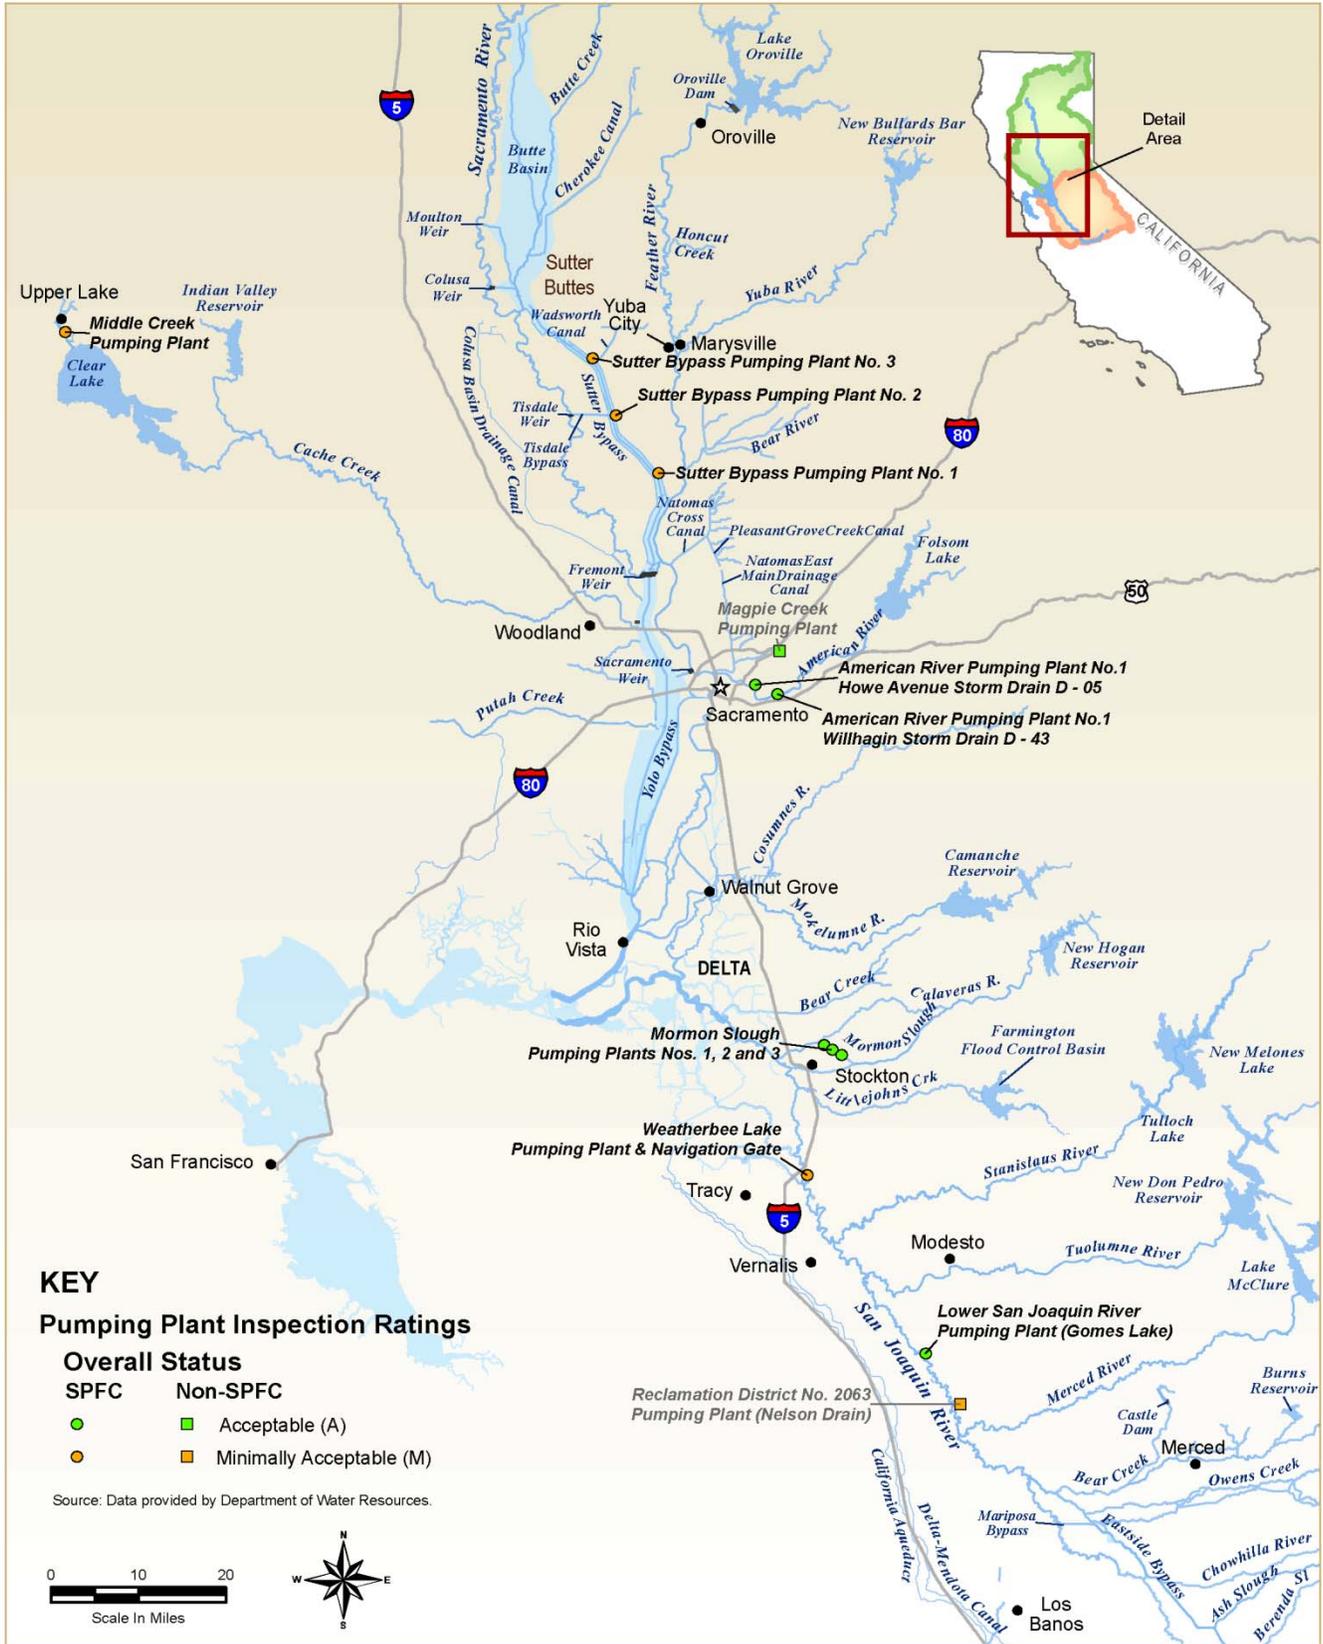
Figure 6-9. Pumping Plant Conditions in Sacramento and San Joaquin River Watersheds

Pumping plant conditions from annual inspections in 2009 (DWR, 2009b) are presented in Figure 6-9 for the Sacramento and San Joaquin river watersheds. Of 13 pumping plants inspected, no pumping plants were rated Unacceptable overall; six pumping plants were rated as Minimally Acceptable.

Ongoing and planned remedial actions and ongoing actions to improve future evaluations are summarized in Appendix C, Section C-2.

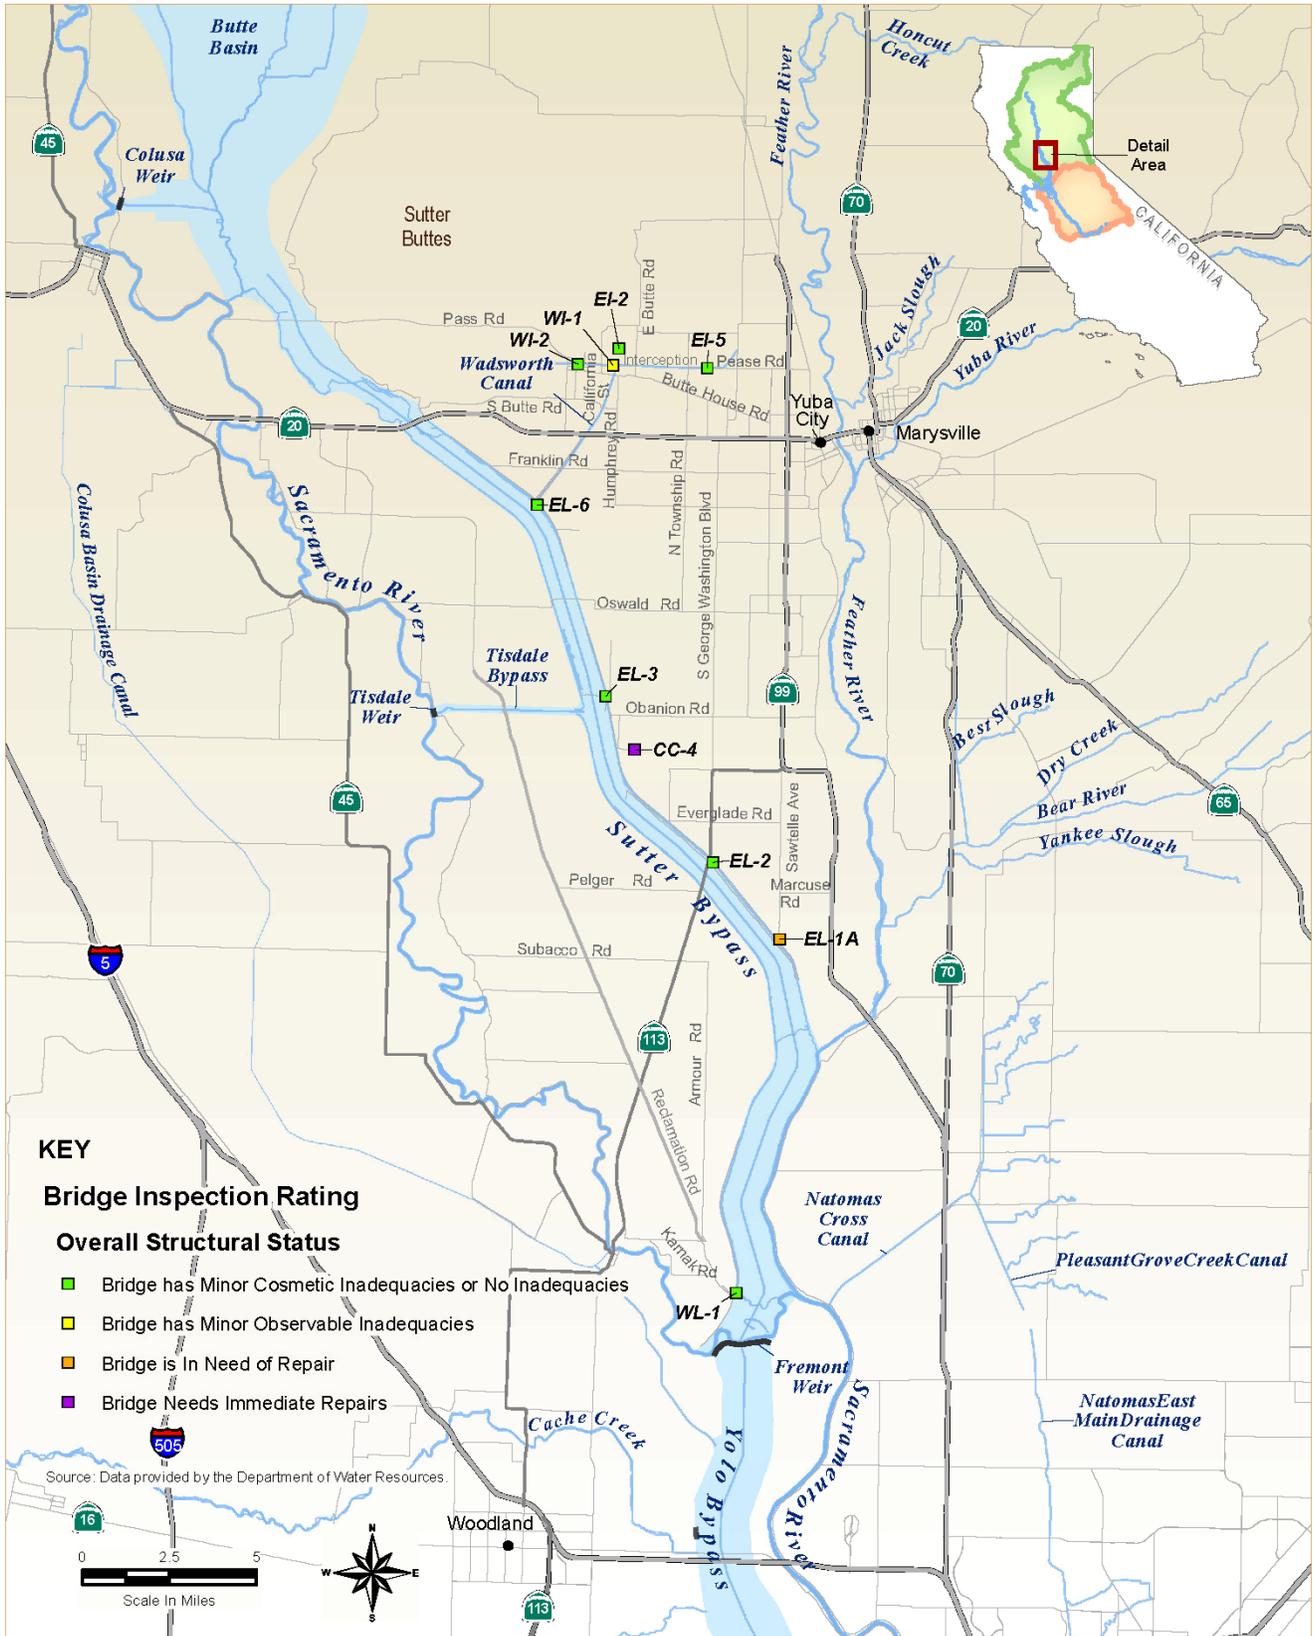
Figure 6-10. Bridge Conditions in Sacramento River Watershed

Bridge conditions noted from the DWR Bridge Inspection Program are presented on Figure 6-10 for the Sacramento River watershed. Detailed description, of the DWR inspections can be found in the DWR *Annual Bridge Inspection Report (2009c)*.

Of the 10 bridges inspected by DWR, 2 had ratings of 4 and 5 overall, and were noted as needing repairs. Since 2000, three Sutter Basin bridges (not inspected by DWR or depicted in Figure 6-10) have been replaced and turned over to Sutter County for future O&M.

Ongoing and planned remedial actions and ongoing actions to improve future evaluations are summarized in Appendix C, Section C-3.
