**Cultural Resources Inventory Report and NRHP and CRHR
Evaluation of the Decker Island South Levee and the Decker Island
Farm for the Decker Island Tidal Habitat Restoration Project,
Solano County, California**

July 11, 2016

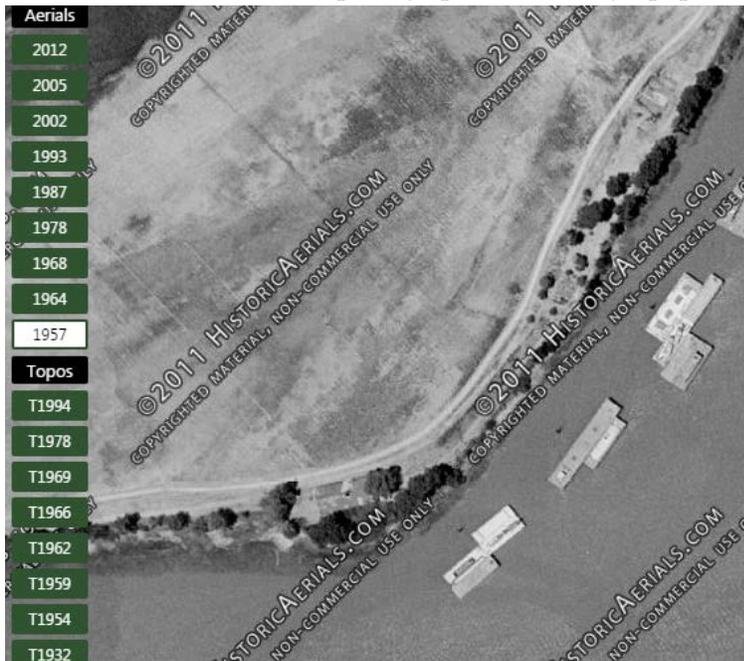
Photo 1. In this 1957 aerial photo the land appears fallow. The barn is visible. There is potentially another structure depicted slightly north of the homestead area.

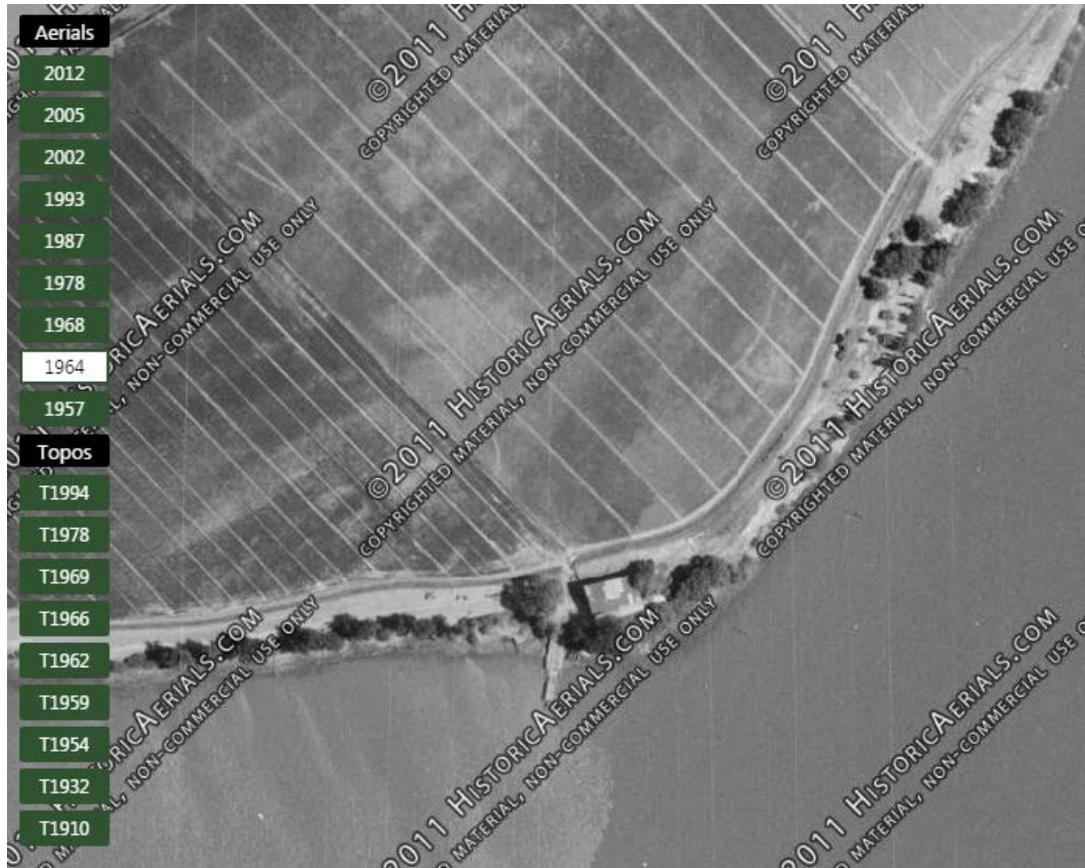
Photo 2. 1964 aerial showing active farming, patched roof, and a new landing by the barn.

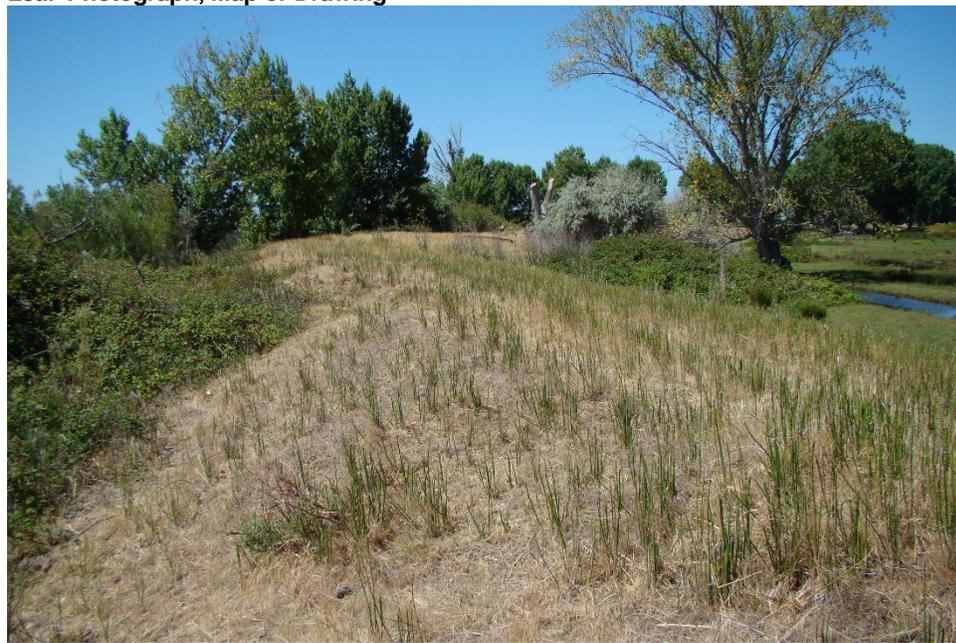
L8a. **Photograph, Map or Drawing**

L7. **Integrity Considerations:** Integrity of location, setting, materials, workmanship, and feeling are still intact. There may never have been an actual design and it is no longer associated with a farming operation; although, the island is still used for some grazing.

L8b. **Description of Photo, Map, or Drawing:** Photo facing southwest along levee.

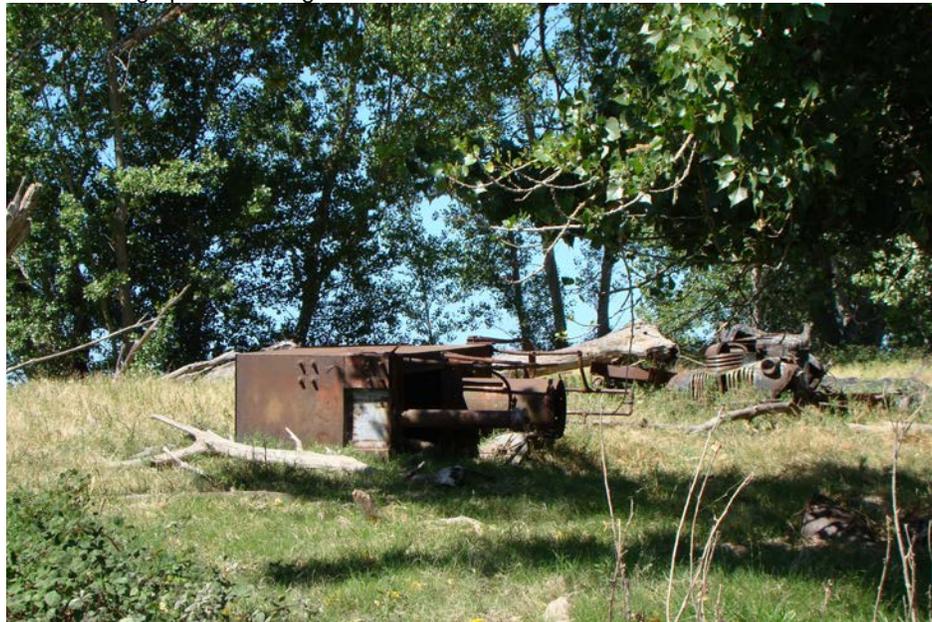
P5a. Photograph or Drawing

*P3a. Description: (Describe resource and its major elements. Include design, materials, condition, alterations, size, setting, and boundaries)
 This resource is the remains of a farming operation and homestead on the island. There are two building loci, one is the burned remains of a barn on the point of the island (locus 1), and the other area is north of the point where the old homestead was located (locus 2). Remains at locus 1 include a burned down barn, coral, fence lines, old vehicles, and farm equipment. Locus 2 has two flats, domestic fruit and nut trees, mechanical farming equipment, a cement block with pipe, and metal pipes sticking out of the ground.

P5b. Description of Photo: Overview of farm machinery -view to NE 6-23-2015

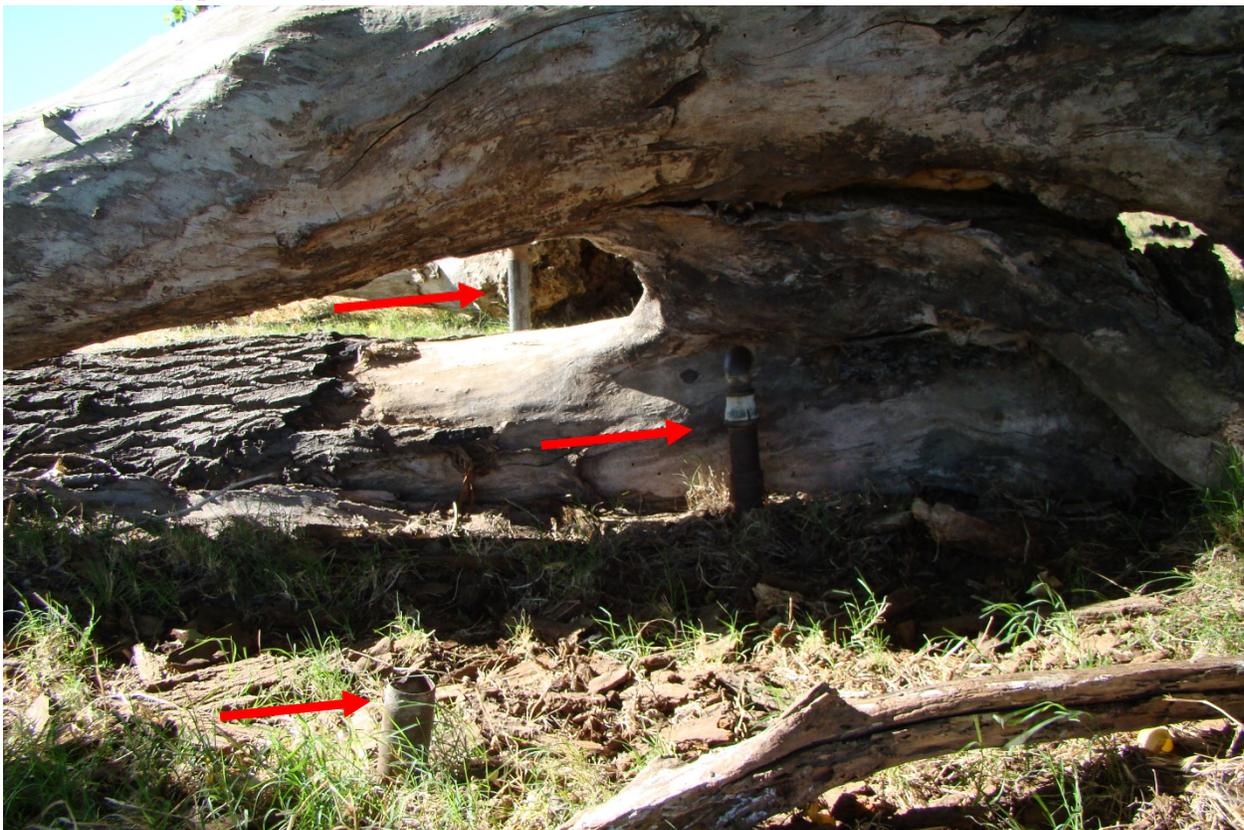
Locus 2: Homestead remains- this area is depicted on the 1910 USGS map as two buildings. It is presumably the residence of Ross and William Hansen who are recorded in the 1910 and 1920 census as residing on and farming Decker Island. This area has two galvanized water pipes (GPS # 10) sticking up out of the ground in a flat. The area where the two pipes are is exactly where one of the buildings on the 1910 map is located. 137 feet to the south of the pipes along the levee is a rectangular flat (GPS # 22) with some sheet metal lying on the ground. Metal detection in this area only hit on shallowly buried sheet metal. No domestic artifacts were found. This flat protrudes into the levee indicating the structure that was here likely predated the levee. While this flat doesn't line up with second building on the 1910 map, it probably was an early structure related to the homestead, possibly a barn or separate residence. A pear, fig, almond, and English walnut are still growing on the flat near these features. There is also a low area in the levee near here which also corresponds to the 1910 USGS map. There may have been a landing at that spot on the river.

A16. Photo of pipes in the ground in cottonwood flat homestead area Locus 2.

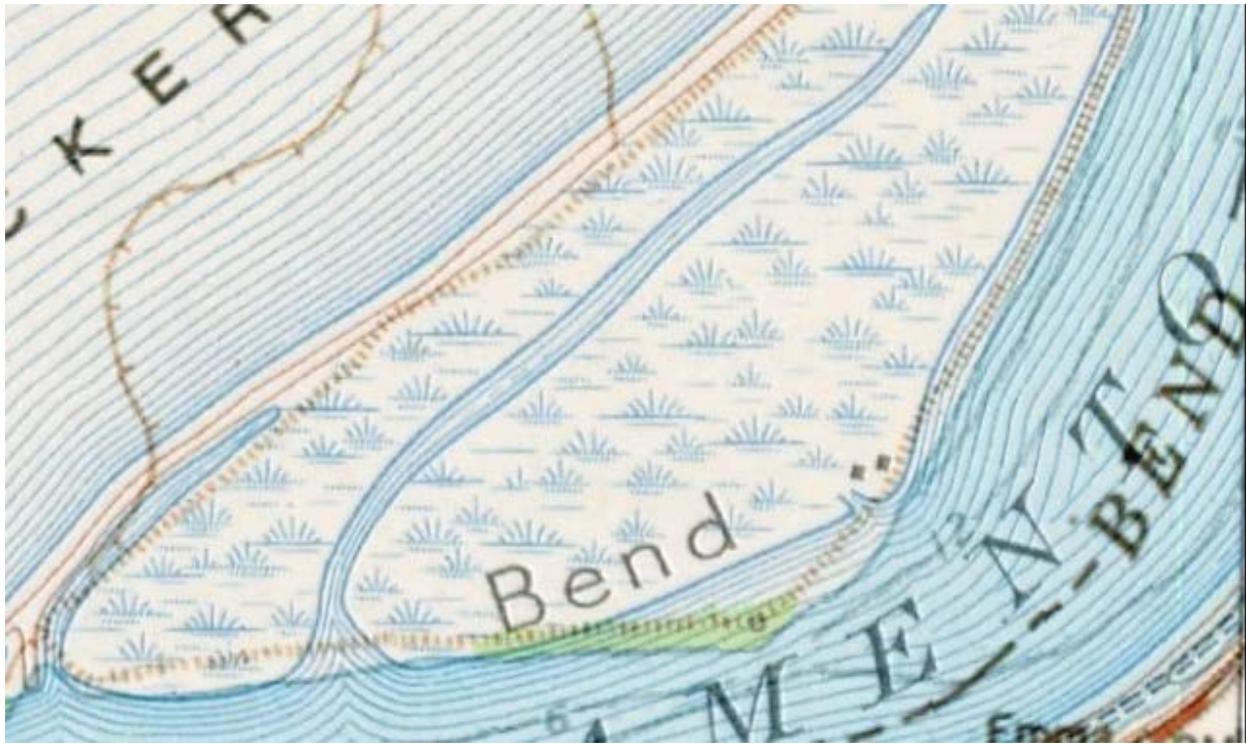
Overlay of 1910 USGS map onto 1978 USGS 7.5' topographic quad sheet showing buildings in Locus 2.

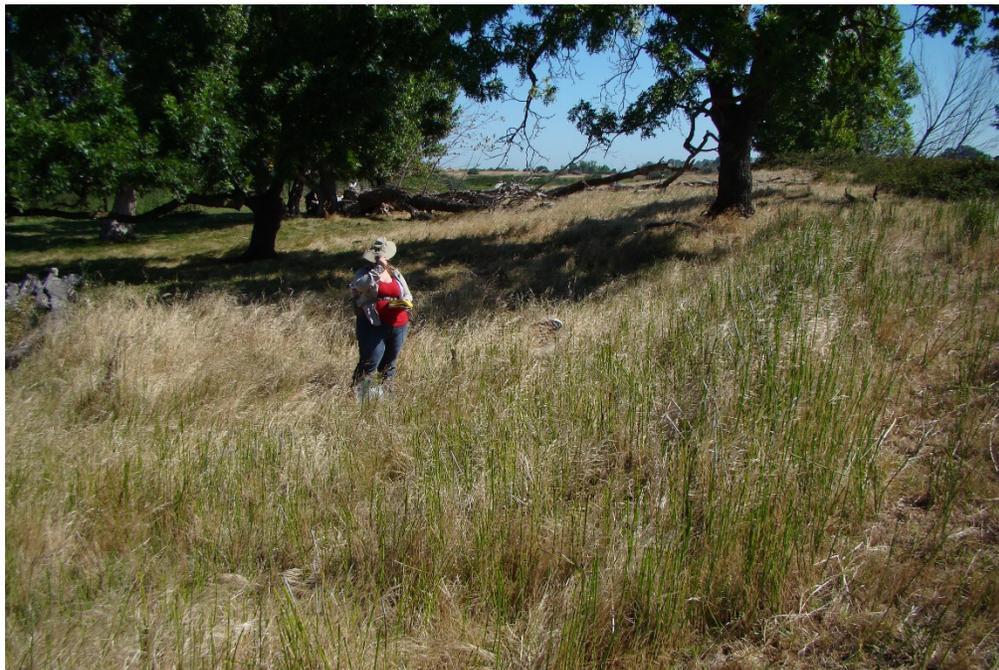
Depression in levee around old building flat.

Photo of Building flat in levee at Locus 2. View north toward cottonwoods with pipes.

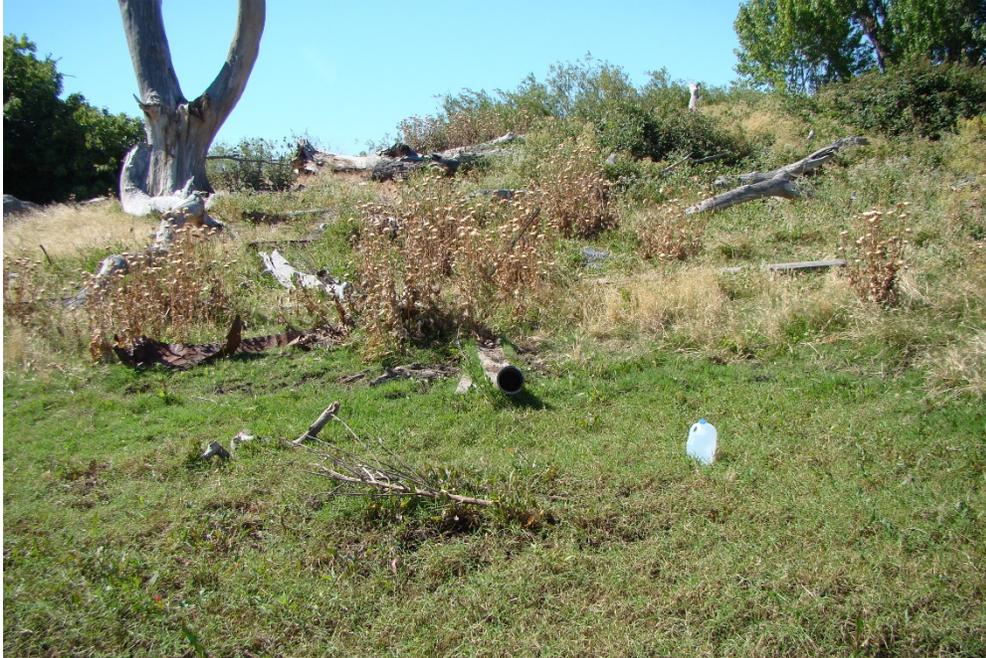
Locus 1: Burned down barn-The corrugated metal roofed and sided barn appears on the 1952 USGS map with culture taken from 1931 aerials. This metal roofed and sided barn was apparently built before 1931 and stood on the island until it burned down sometime between 1978 and 1987. Directly to the west of the barn is a fenced coral area, with a cattle chute and beyond that are hulks of a 1941 Chevy truck, a circa 1930s Dodge truck, and some other farm machinery and unidentified vehicle remains. Two large wheels with "Stockton Iron Works" embossed on them were found near the barn. One appeared to have a differential attached to it.

Photo of Locus 1 burned barn area. View to SSW.

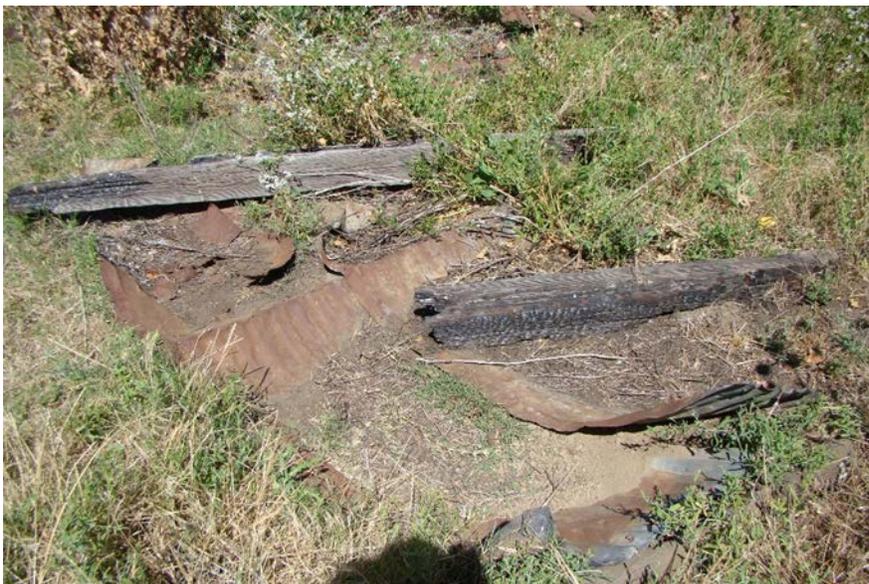
Burned remains of barn structure.

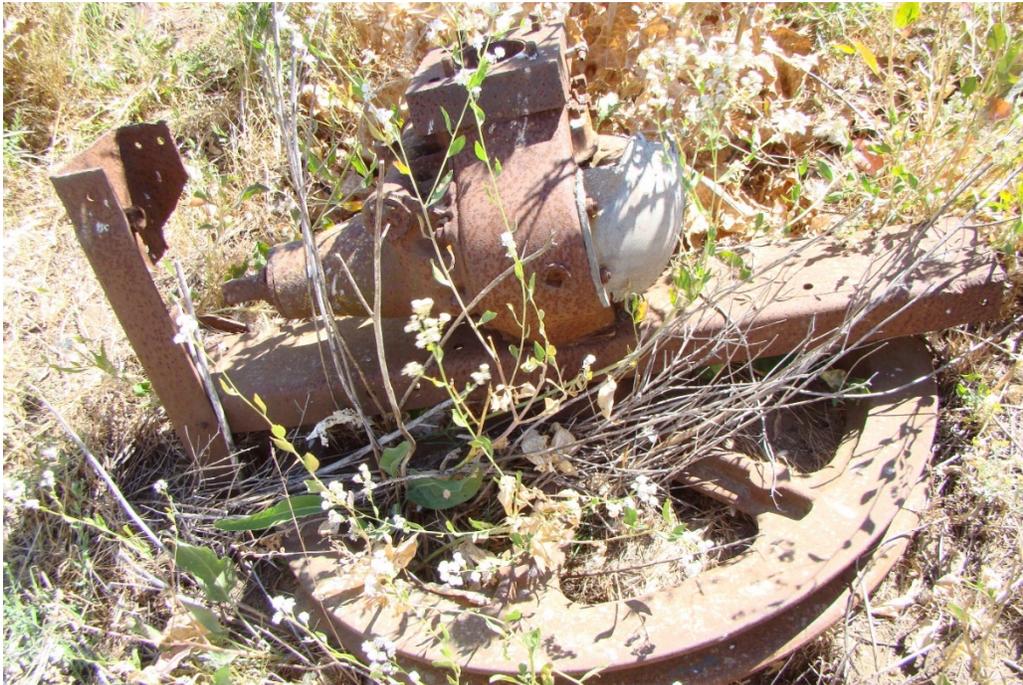
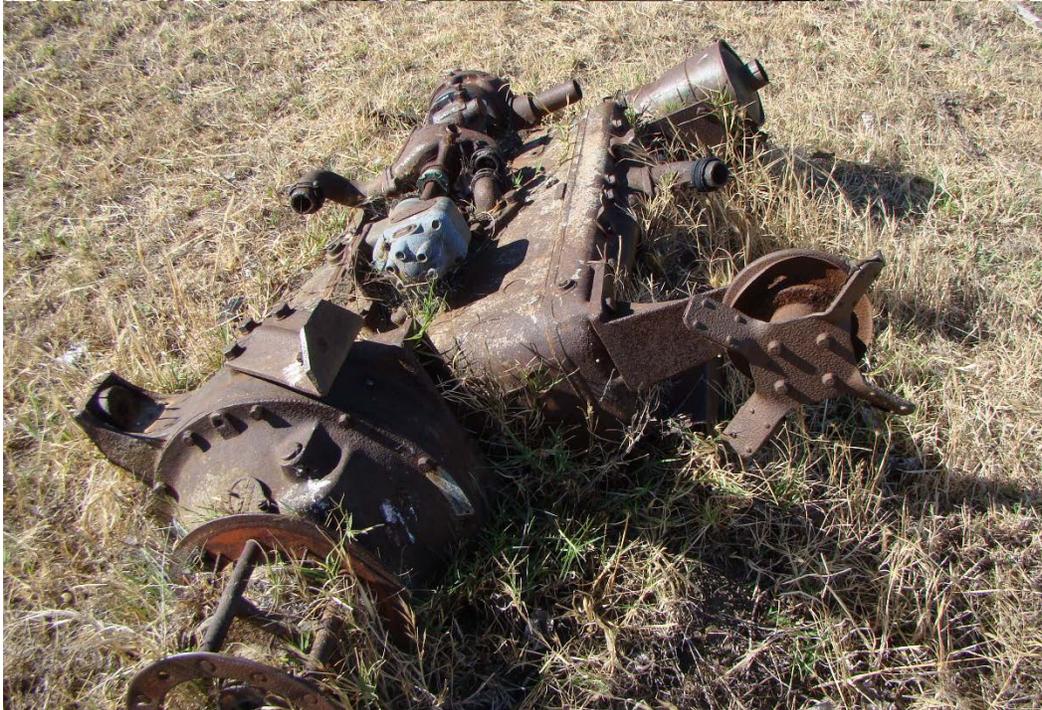
Farm equipment – hand cranked engine (bottom).

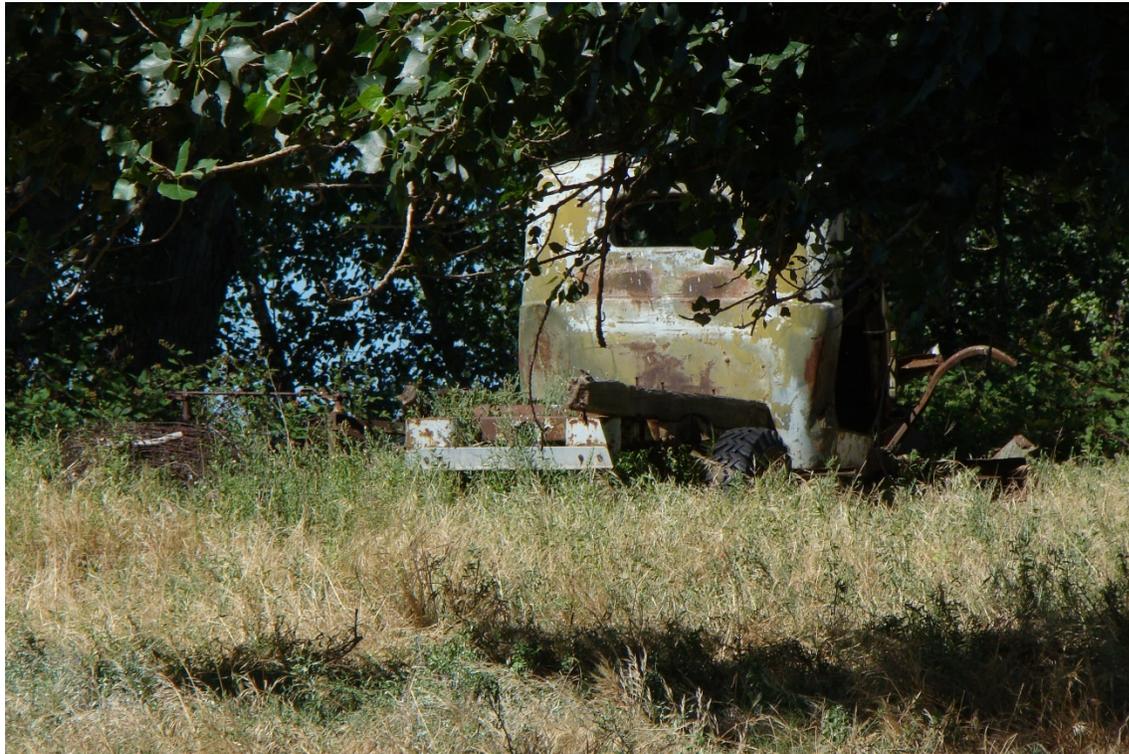
1930s-era Dodge Truck
